Transport safety alert

12 April 2012 | TSA no. 40

Catastrophic failure of freight axles in the barrel area

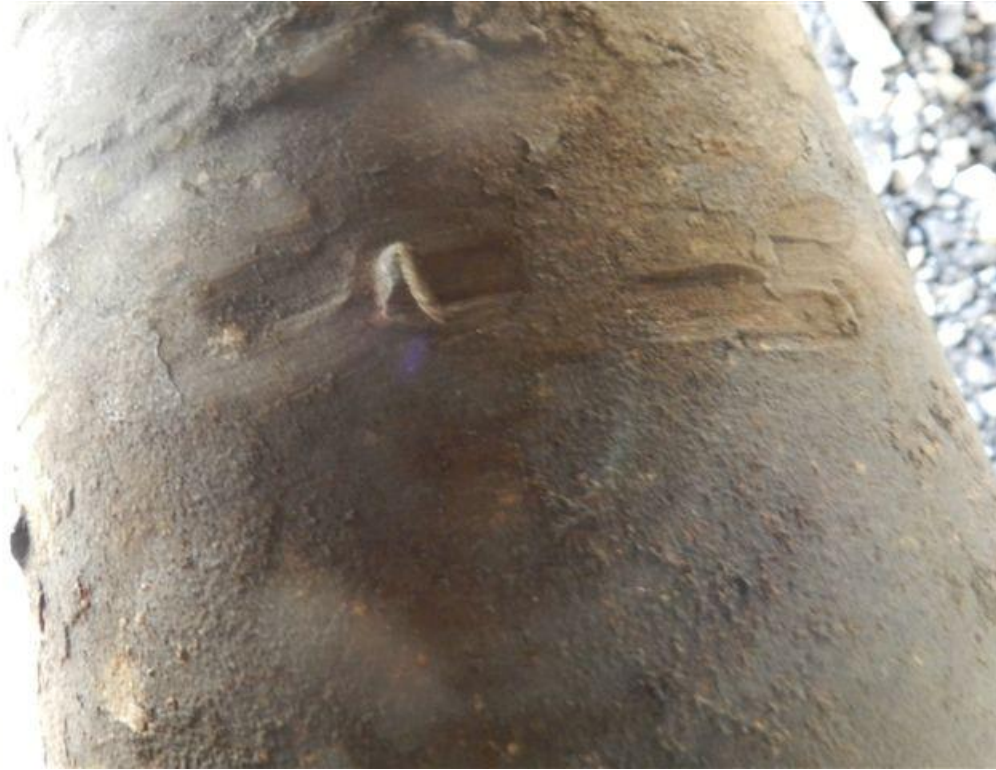
A significant defect found on this axle was easily detected on the day of the inspection by feeling the abrupt surface surrounding the defect. These heavy transverse gouge marks, which were evident near the axle centre (refer to Figure 1), were likely to have been present for some time. The axle was last inspected in February 2010. It should have been rejected (unfit for service) if examined as per the requirements of the transport operator's axle re-qualification standard.

Figure 1: Axle A, heavy transverse gouge marks

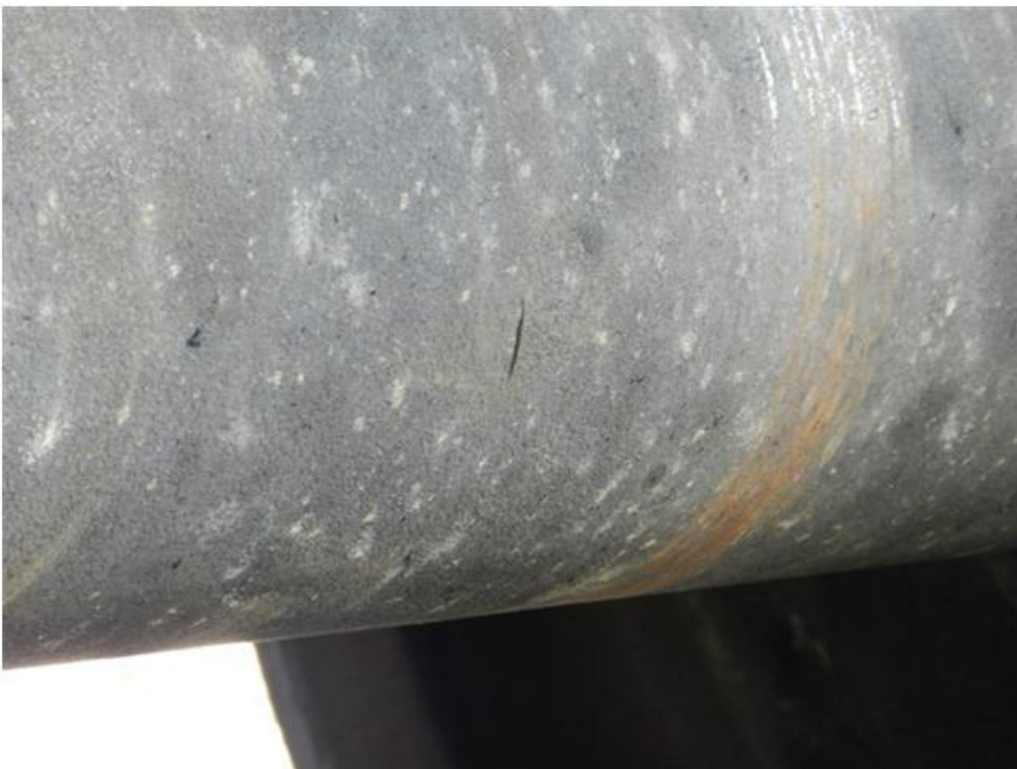
A small sharp transverse cut was found on this axle on the day of the UTM (refer to Figure 2). This particular defect would — as a minimum — warrant attention in compliance with the transport operator's axle re-qualification standard. The axle was last inspected in July 2011.

Figure 2: Axle B, small sharp transverse incision

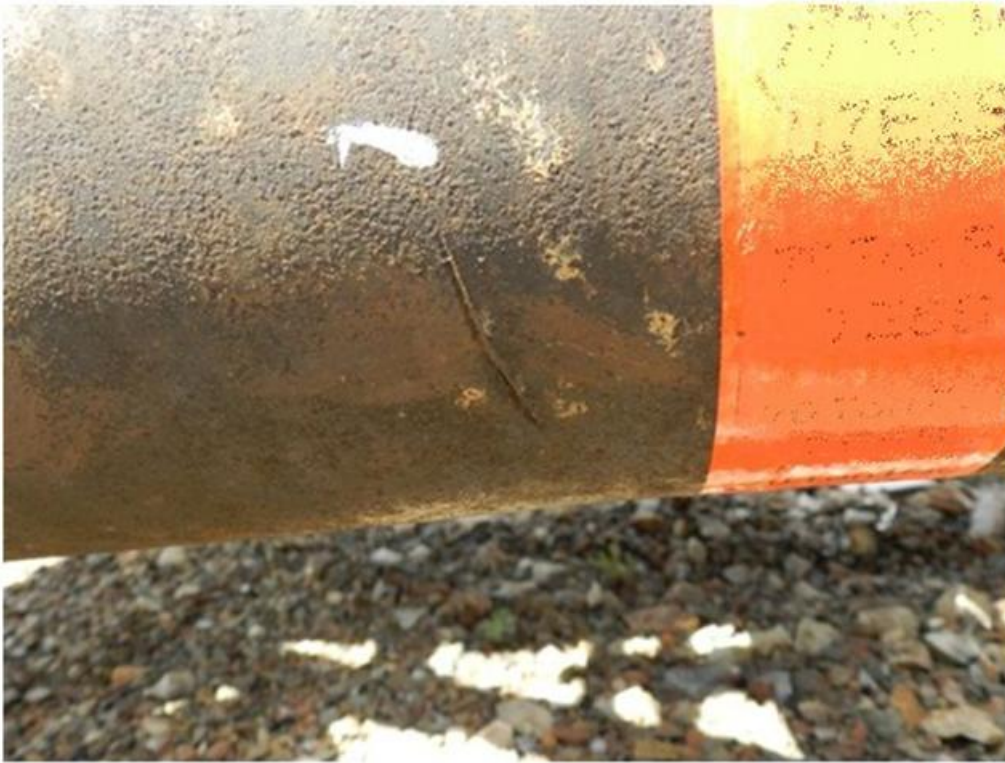
A small number of freestanding, recently overhauled freight bogies — awaiting to be fitted to wagons — were inspected in the yard. This particular axle had two separate defects: a heavy impact mark; and a long transverse incision (refer to Figures 3 and 4 respectively). These defects would warrant remedial action (and most likely rejection) in compliance with TRS 1447. The wheelset received attention as recently as March this year as part of the bogie overhaul process.

Figure 3: Axle C, long transverse cut

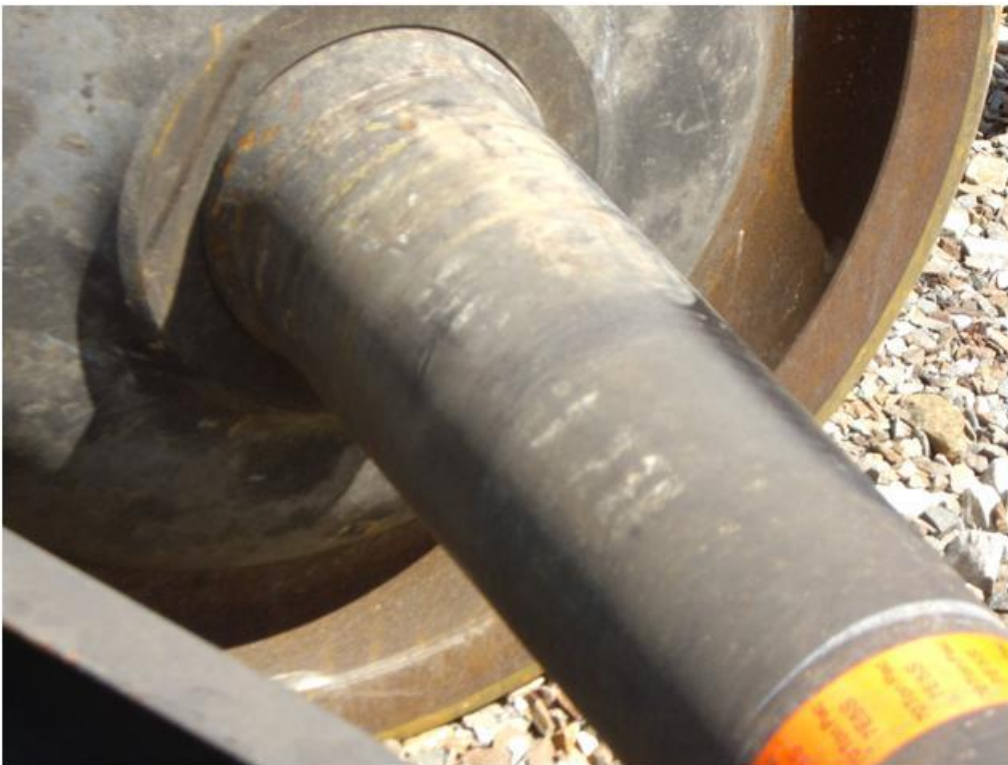
Figure 4: Axle C, transverse impact mark

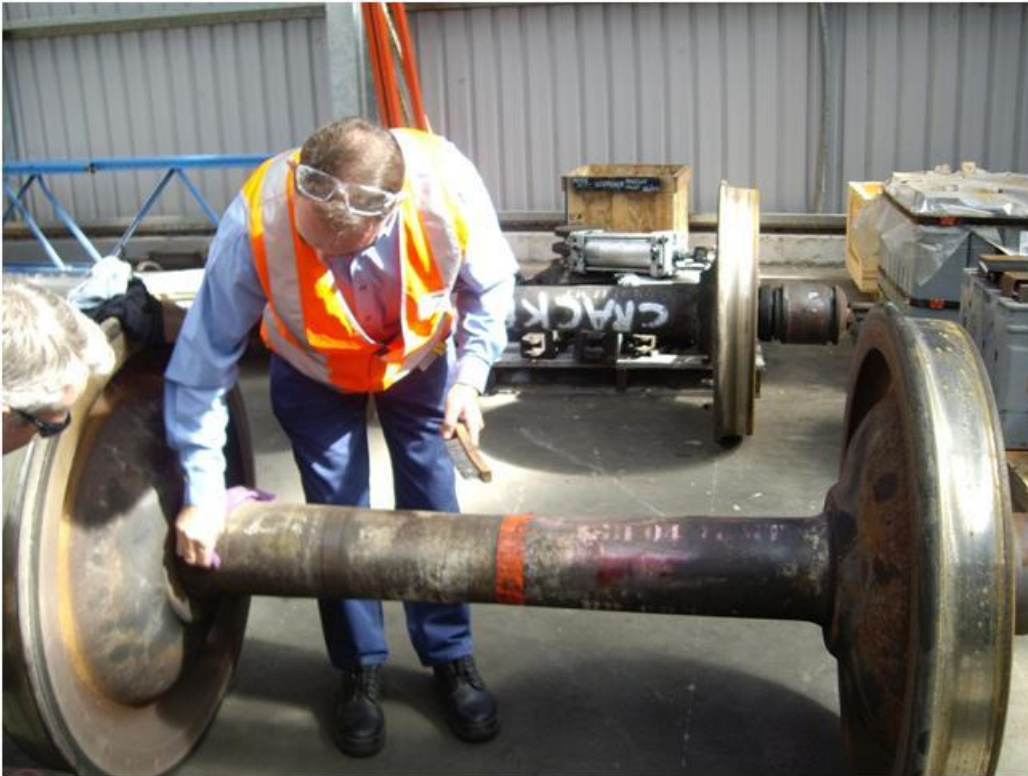
Two axles that had previously been ultrasonically tested were withdrawn from service due to the presence of defects found in the axle barrel (refer to Figure 5). Both axles were in the freestanding state awaiting further examination in the near future. One was a Chinese-manufactured axle with sub-surface defects and the other (axle D) displayed heavy abrasion marks just inboard of one of the wheels (refer to Figure 6). Although not evident at the time, this axle also had two heavy indentations in the centre of the barrel. These indentations were obscured by the identification tape (refer to Figures 6 and 7) which was applied at the maintenance facility. The tape did not show any damage that would indicate it had been applied post or after the impact marks. The damage sustained by this axle is most probably post derailment related. The axle was last inspected in August 2011 and should have been rejected (unfit for service) if examined as per the requirements of the transport operator's axle re-qualification standard.

Figure 5: Axle D (foreground); Chinese-manufactured axle found with sub-surface defects (background).

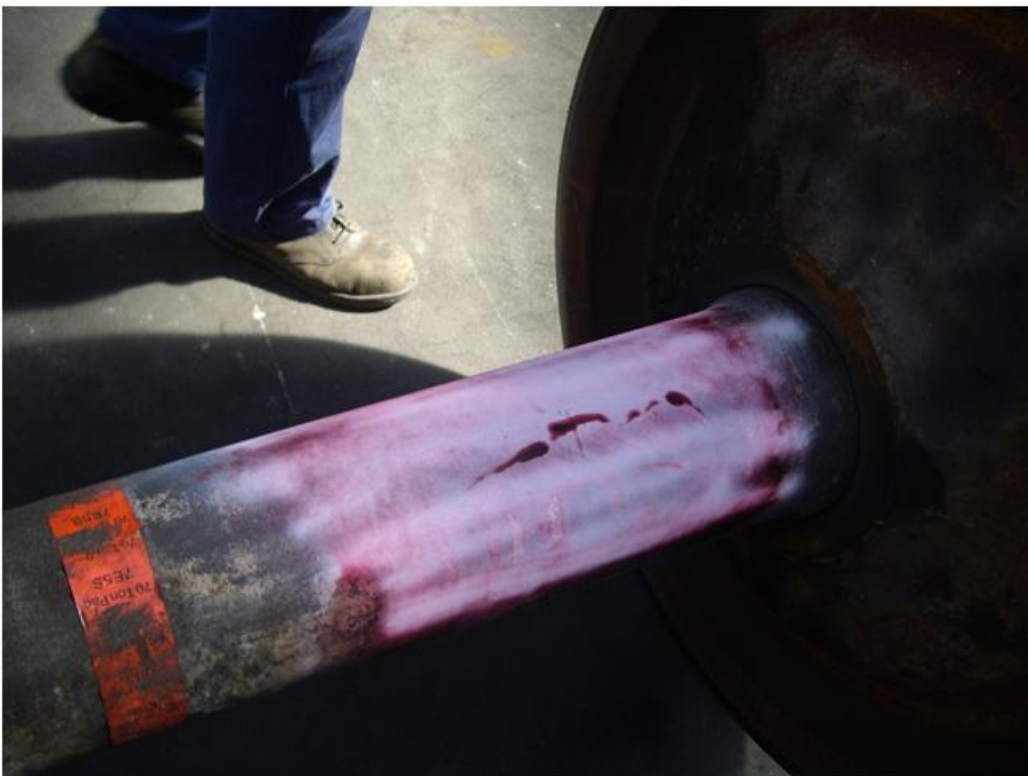
Figure 6: Axle D, significant abrasion marks. Note the identification band still wrapped around the centre of the axle.

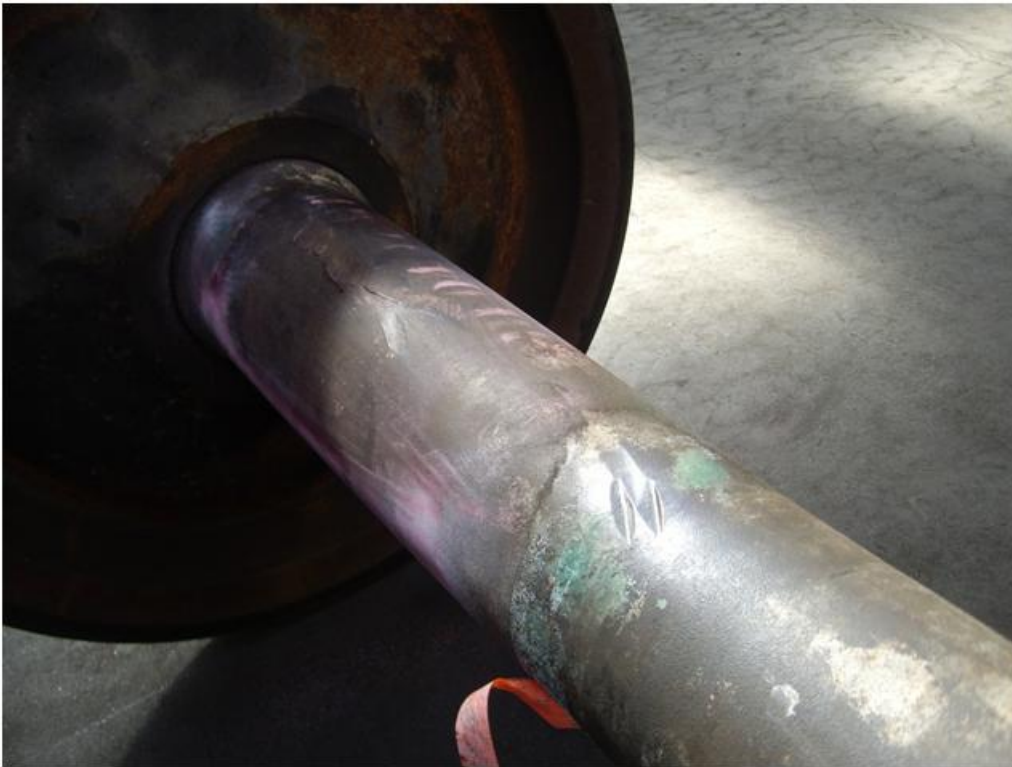
Figure 7: Axle D, heavy impacts marks evident after the identification tape had been partially removed.
