Rail Industry Safety Notice

RISN No 1 / 2012

RAIL SAFETY INVESTIGATION REPORT

COLLISION BETWEEN HI-RAIL AND RAIL MOTOR

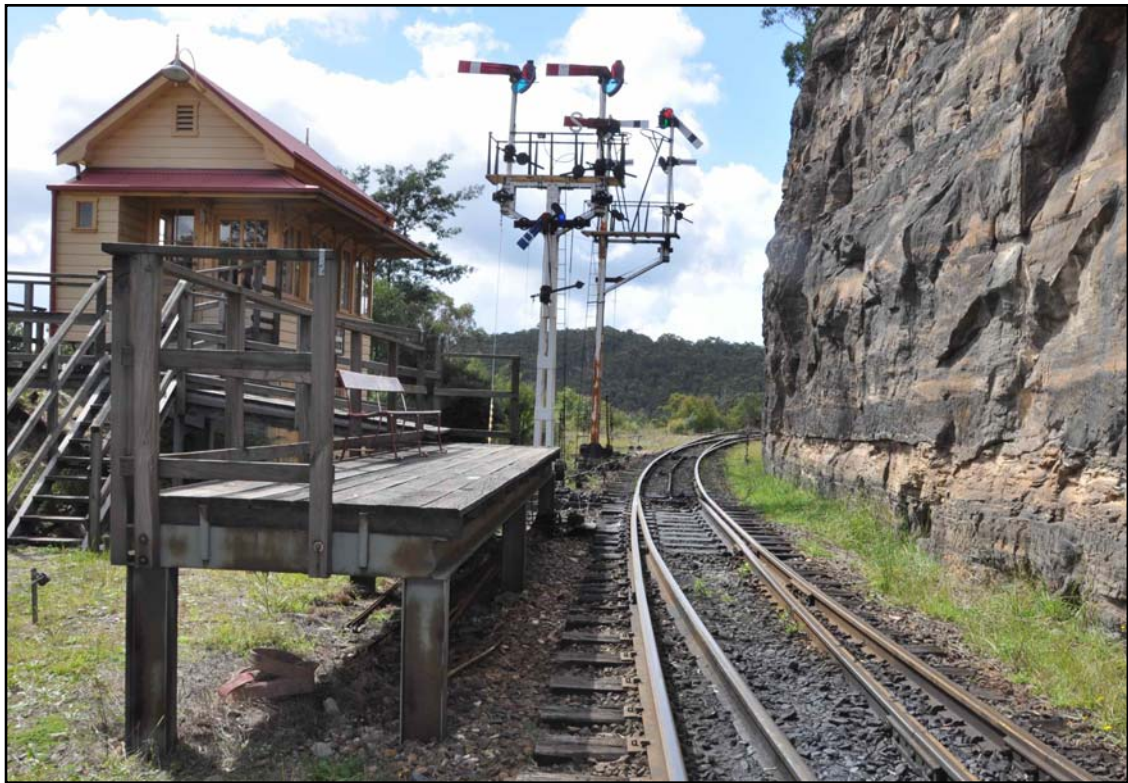
Photograph 2: Top Points Signal Box and Signals

- 1.19 On arrival, the Rail Motor Driver entered the Signal Box, saw the Staff on the table inside the door and made the decision to take the Staff to the Hi-Rail which he believed to be stationary at the worksite. The Rail Motor departed Top Points with the Staff. The Rail Motor Driver did not have a hand-held radio nor was there a fixed radio in Rail Motor 2016, and he did not discuss with the Guard his intention to leave Top Points Signal Box. The Guard, who was taking passengers on a tour of Top Points Station and the 1901 runaway site, had no visibility of the Rail Motor which he believed to be waiting for him at Top Points Signal Box.

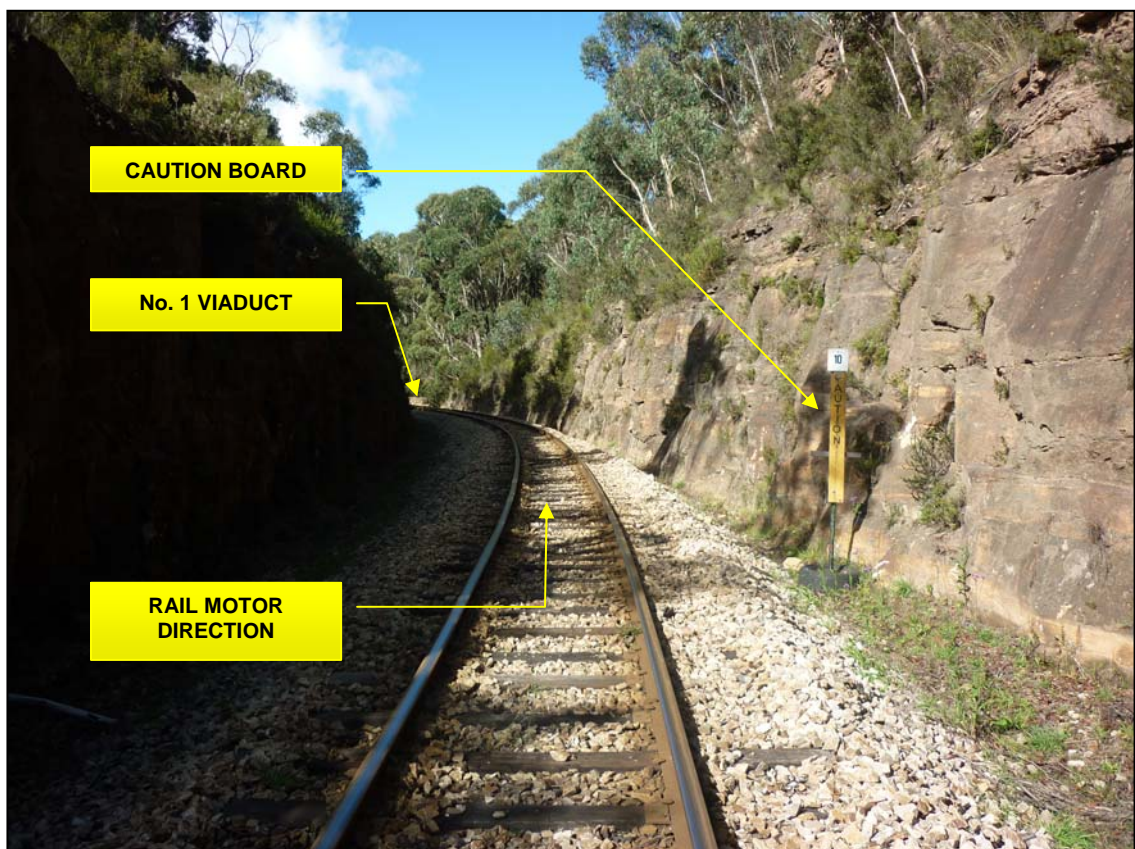
Photograph 3: View from Rail Motor towards No.1 Viaduct

- 1.24 As the Rail Motor approached the Viaduct, the Driver said that he looked down to check his instruments and, when he looked up again, saw the Hi-Rail about 50m away. He immediately applied his brakes and then cut back the throttle. He said that he did not sound the Rail Motor horn as he had his hand on the brake and did not want to remove it.

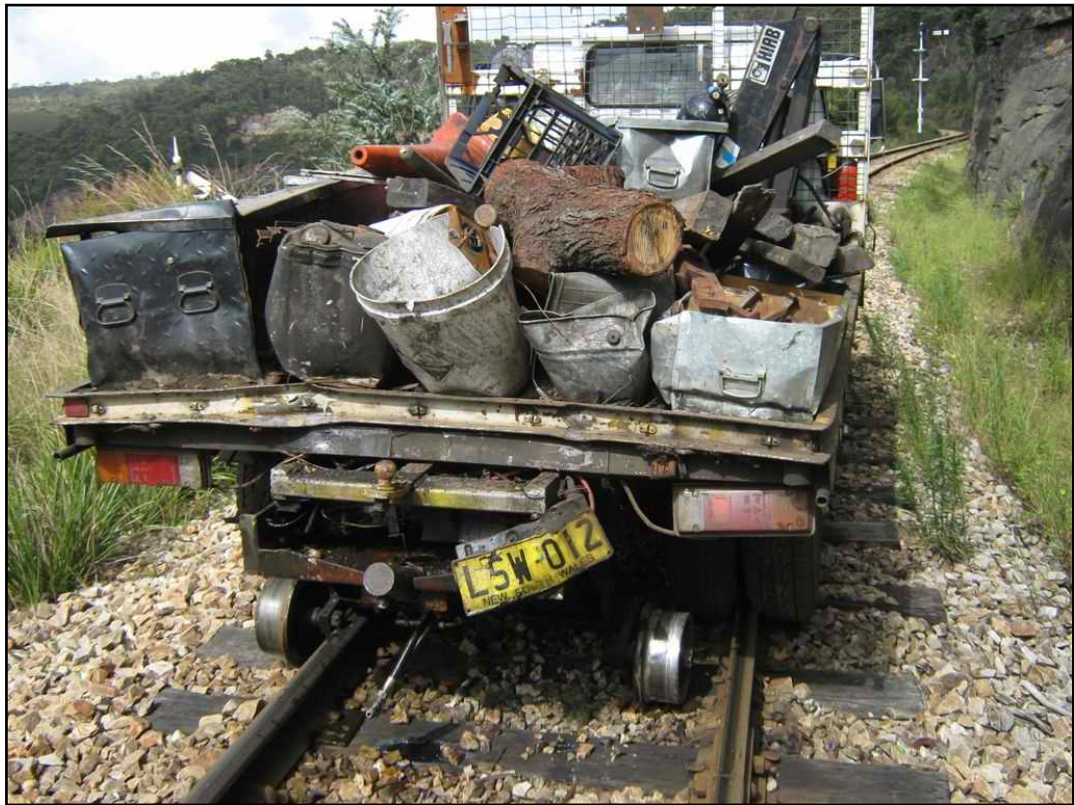
Photograph 5: Hi-Rail after collision

- 1.28 The force of the collision compacted the body of the Hi-Rail cab such that neither cab door would open. The Driver and Passenger were assisted from the cab through the open side windows by the Rail Motor Driver. All three persons then boarded the Rail Motor. The Hi-Rail's towbar had punctured the Rail Motor's stainless steel body causing the two vehicles to be locked together.

- 1.34 The Rail Motor Driver was uninjured. However, the Hi-Rail Driver was rendered unconscious briefly and reported a sore lower back, shoulder and legs while the Passenger suffered a bruised spine and temple.
- 1.35 As a result of the collision the Rail Motor and Hi-Rail became locked together with damage to both vehicles (see *Photographs 5 & 6*).

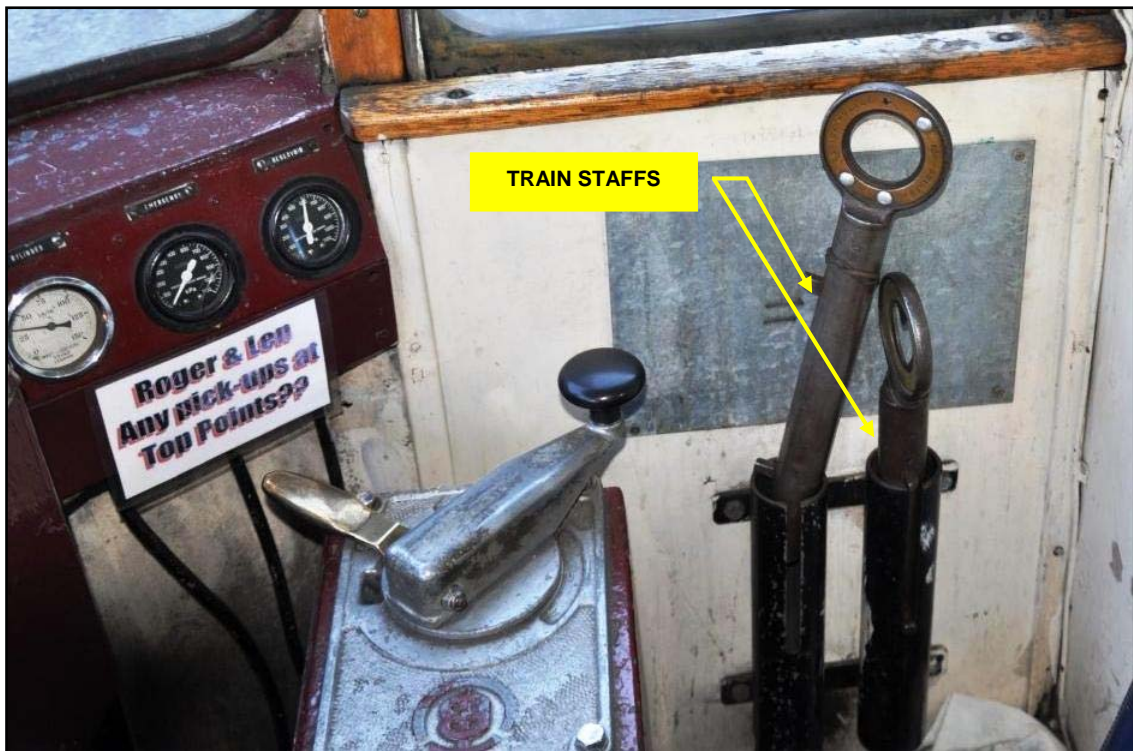
Photograph 10: Both Staffs in receptacles in Rail Motor Cab

- 4.11 It was accepted practice for both Staffs being kept in the Lithgow end of the Rail Motor. This increased the probability that the required check, that the correct Staff was at hand, was not done if the Rail Motor was driven from the Clarence end. [Recommendation 5.2]

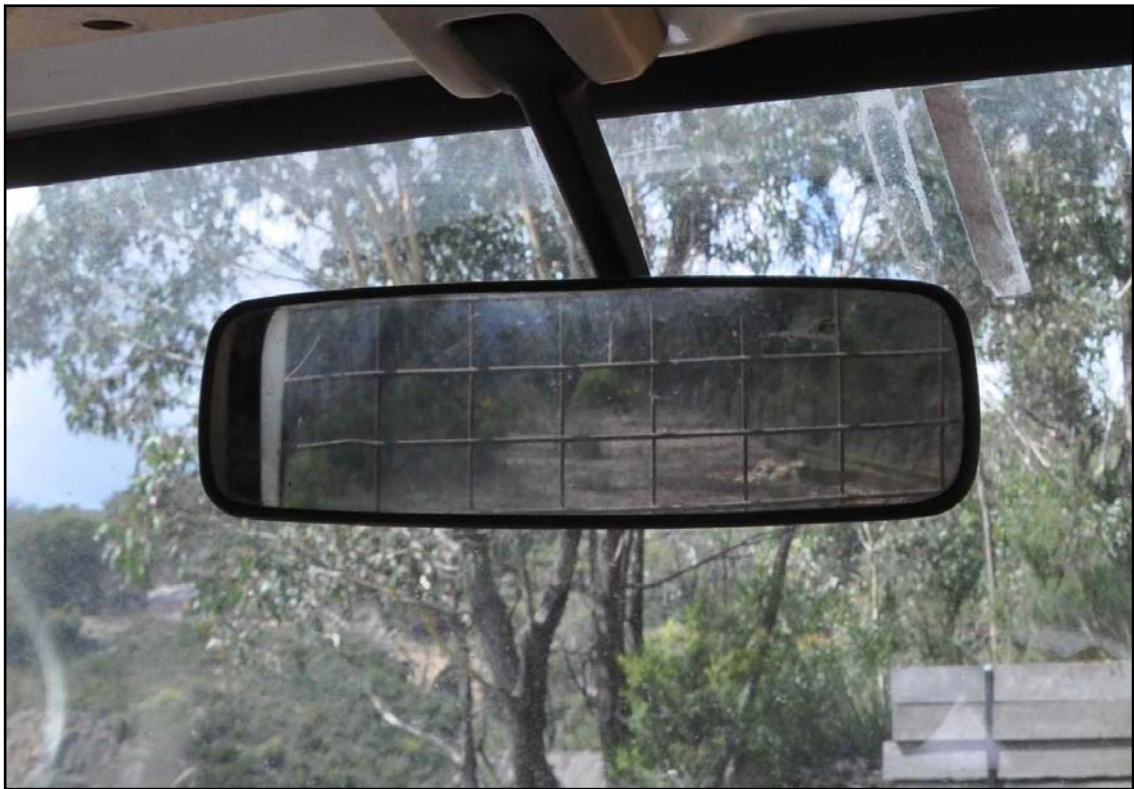
Photograph 11: Rear view mirror

- 2.24 When the Hi-Rail was travelling from Clarence to Top Points, immediately before the collision, the Hi-Rail was not facing the direction of travel. It was incumbent on the Hi-Rail crew, therefore, to keep a lookout while reversing, either by checking their mirrors or turning and looking through the rear window. The Hi-Rail Driver stated that he did maintain a lookout using the vehicle's rear view mirrors but that he did not see the Rail Motor. Unlike looking ahead through the windscreen, observing images in rear view mirrors requires a deliberate act which involves some effort and concentration (see *Photograph 11*).

- 4.3 The Driver of the Hi-Rail was unable to take any emergency action to prevent the collision because he was travelling backwards down the track and neither he nor his Passenger was maintaining an effective lookout. [Recommendation 5.2]
