Rail Industry Safety Notice

RISN No 5 / 2012

TRAIN BRAKE PIPE OBSTRUCTION FLEXIBLE AIRBRAKE HOSE

TECHNICAL ALERT – SIGRA railway Airbrake hose made to AS2435

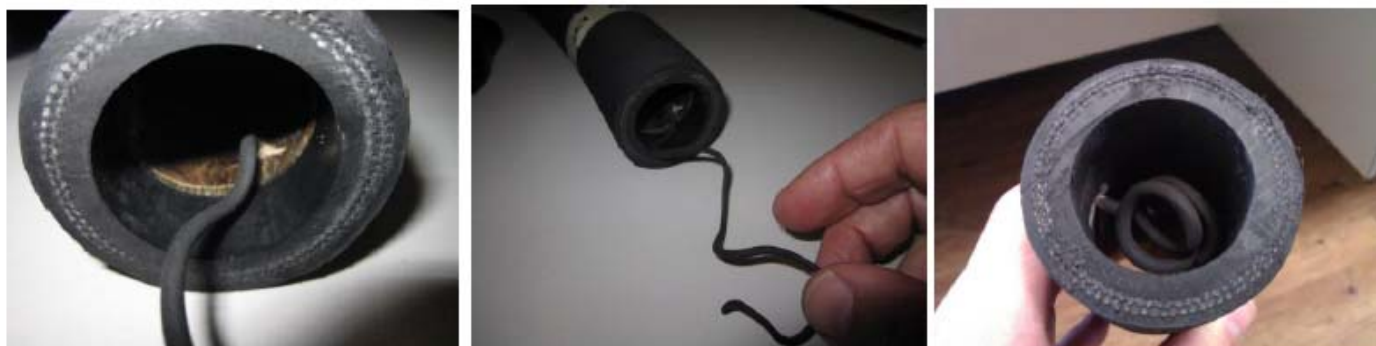
The incidence of Oring cord like projections from the internal wall of 29.5mm and 35mm ID hose has been detected.

The centre mandrel can have holes in the surface for the injection of compressed air to aid in the removal of the mandrel after manufacture. These holes are covered with paper tape to prevent rubber extruding through the hole. In 29.5 and 35mm ID hose, the bulk of rubber is more than in smaller sizes, and there have been incidences of the paper tape breaking, allowing rubber to be extruded into the hollow mandrel. Such projections can range from 10 to 20mm long and up to 250mm long.

The rubber is similar to Oring cord and is 3mm diameter. These extrusions would normally snap off when the mandrel is withdrawn, and Sigra checks cut hose lengths to ensure there are no internal deformations.

Current and future hose manufacturing batches will not use mandrels with air holes, air will instead be injected using a cone tool through the end of the hose. Extrusions will not be possible with this system.
