# Rail Industry Safety Notice

**RISN No. 17**

## **Warning of Potential Locomotive Bonded Asbestos Material**

## Warning of Potential Locomotive Bonded Asbestos Material

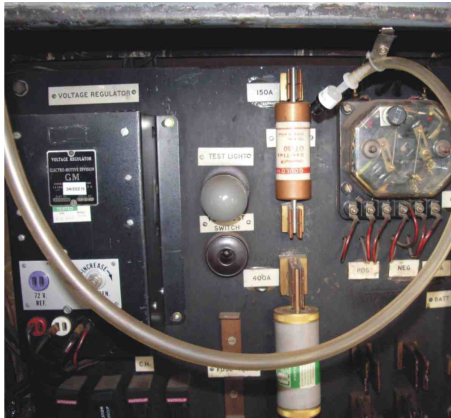
Cabin fuse & battery knife switch backing board in a Y class locomotive

A program is being developed to remove all asbestos bearing material that is identified in the arc chutes across the locomotive fleet. The material present in the electrical backing boards is of the bonded type, and therefore unless obviously damaged or mechanically disturbed, does not require systematic replacement.

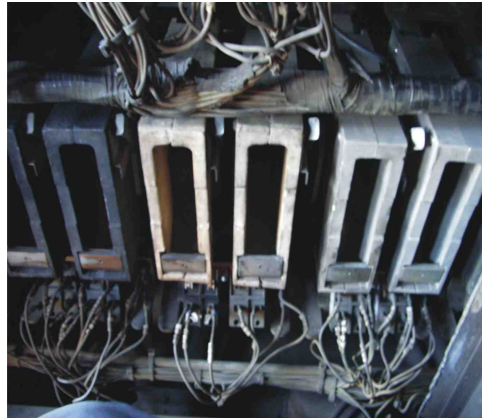
Engine room arc chute in an X class Locomotive. The black coloured arc chutes to the left were found to contain bonded asbestos.
