# Rail Industry Safety Notice

RISN No. 23

## POTENTIAL DEFECTS IN SPOKED WHEELS AND DRAWHOOKS

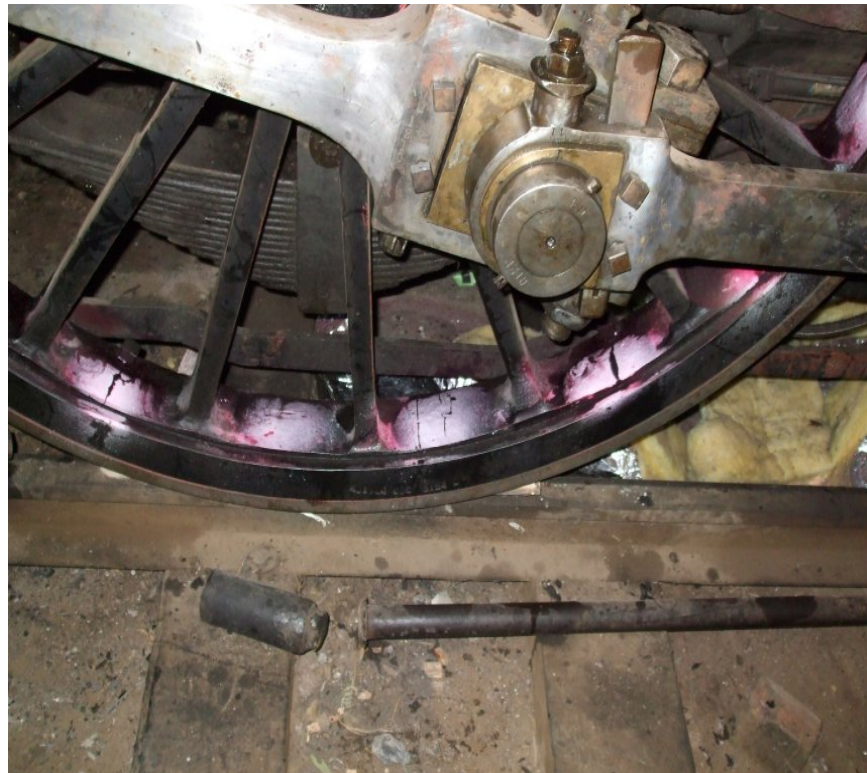
A set of cast driving wheel centres from a steam locomotive was recently scrapped due to the presence of fractures located between the spoke junctions (i.e. segments) on the inner diameter of the wheel rim (see Figures 1 & 2 below). Of the 10 segments on one wheel centre, 8 were found to be cracked and of the 11 segments tested on another wheel centre, 6 were also cracked.

**Figure 1 – Inner wheel rim surface showing transverse fractures on several segments**

Hence, it is imperative that the condition of these wheel centres is ascertained given their extensive age and the fact that they have not been subjected to regular monitoring in the area of the inner wheel rim.

In view of the above, the Independent Transport Safety and Reliability Regulator (ITSRR) requests that accredited persons and/or rolling stock maintainers in NSW who operate and/or maintain heritage rolling stock develop and implement an appropriate NDT regime to confirm the structural integrity of drawhooks (over the entire length) and spoked wheels (includes the wheel rim, spokes and wheel hub).

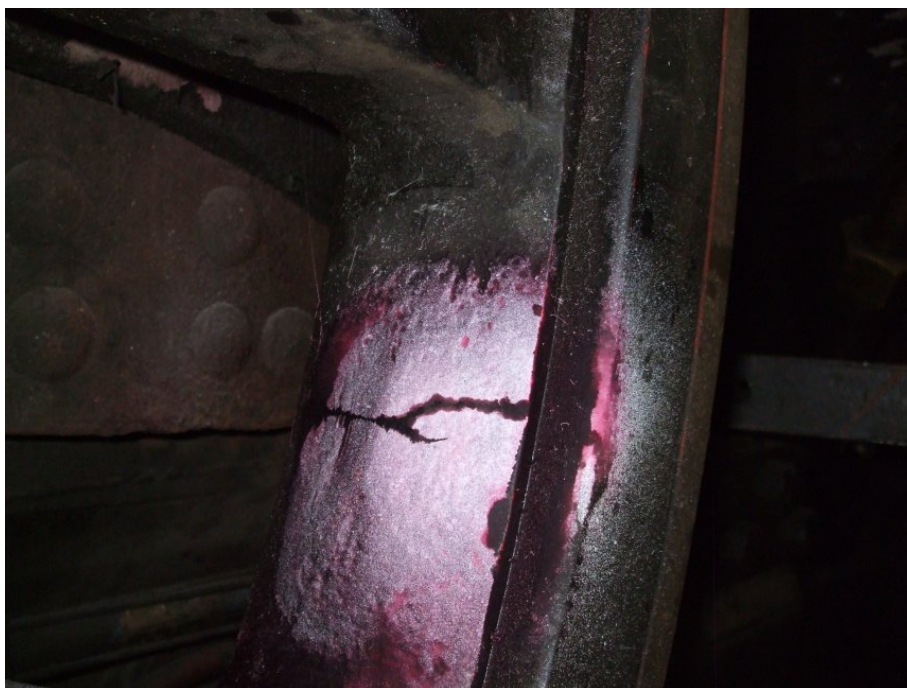
**Figure 2 - Close-up view of one of the transverse fractures**

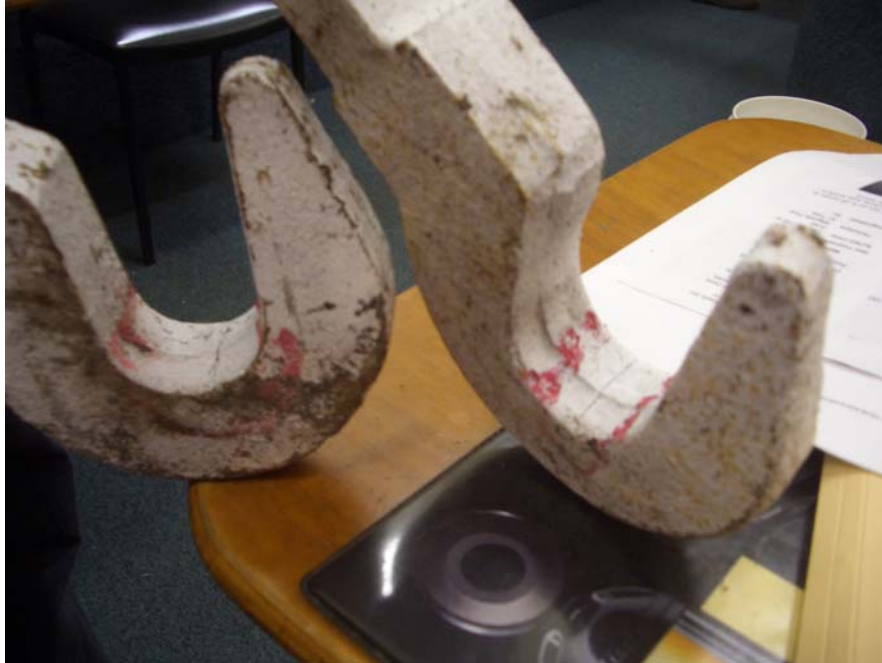
A heritage operator recently carried out a series of Non Destructive Tests (NDT) on a number of drawhooks used on heritage rail motors and found a high percentage with fractures (refer to Figures 3 & 4). In cases where cracking was evident, the initial fluorescent Magnetic Particle Inspection (MPI) test was followed by a black and white MPI in order to highlight the defects found.

Figure 3 - Two drawhooks showing fractures on the inner contact surface

A high percentage of drawhooks were found with fractures (refer to Figures 1 & 2) which led to these drawhooks being replaced.

Given the age of the drawhooks, the lack of any NDT requirements (as part of a technical maintenance plan) in the past and the findings from a RAIB (UK) report (Locomotive Runaway near East Didsbury on 27 August 2006) relating to a failed drawhook in service, there is a need for relevant rail operators to institute a NDT regime to ensure the structural integrity of these drawhooks on an ongoing basis.

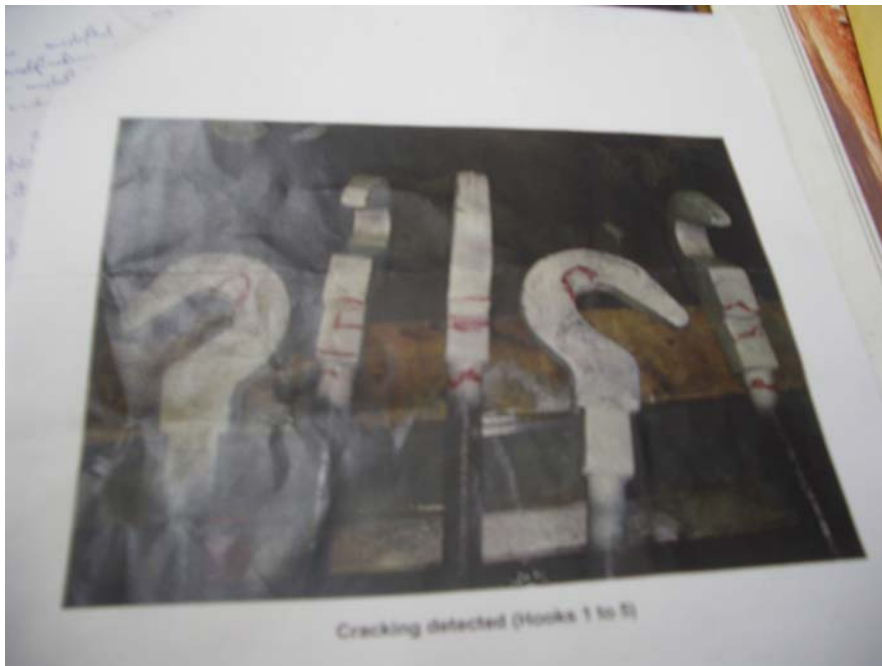
Figure 4 - Five drawhooks with defects highlighted at various locations
