Rail Industry Safety Notice

RISN No 3 / 2009

BALLAST REGULATOR – SYSTEM FAILURE

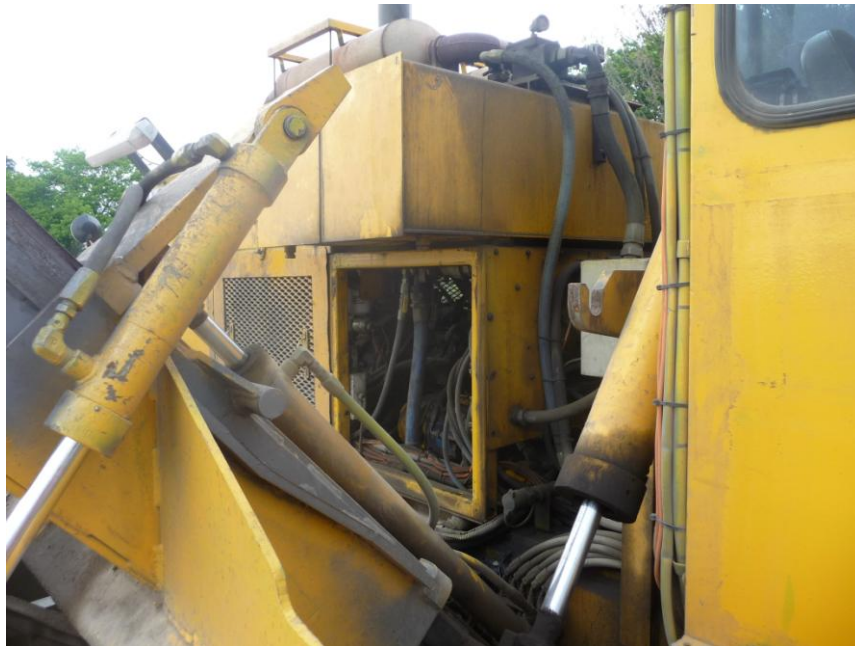
The Rail Safety Unit (Tasmania) has recently completed an investigation into a collision between a freight train and a stabled ballast regulator. The collision was due to the ballast regulator side wing being left foul of the running line. The regulating wing restraining pin had most likely been placed in the holding cradle when regulating activities were completed, but the hydraulic controls were inadvertently leant against by a passenger travelling in the vehicle prior to the machine being stabled. Tests have shown that if the wing is left raised above the cradle when the machine is shut down, over several hours it will fall down and away from the vehicle as the hydraulic pressure drops away potentially fouling adjacent tracks.

1. The regulating wing having dropped away from the holding cradle.

Accredited Rail Transport Organisations either using hydraulically operated ballast regulators or engaging service providers who use these track machines need to be aware of the potential for this type of incident to occur. The issue of instructions to their staff or service providers to check that the regulating wing is securely restrained after the machine has been shut down is recommended. Alternatively an engineering solution to minimise the risk of the operating levers being able to be inadvertently moved needs to be considered by affected parties.

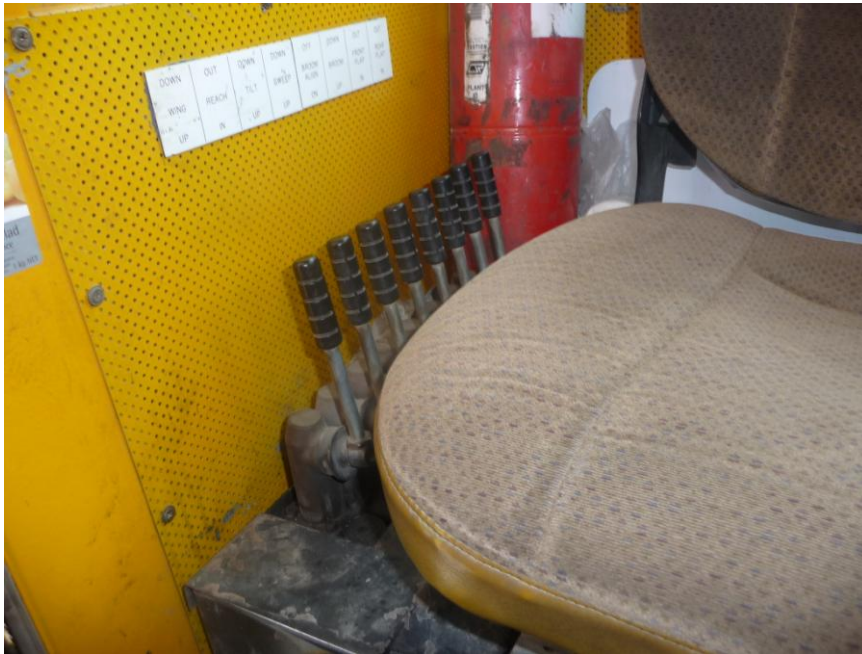
2. The position of the hydraulic controls next to the operator's seat.
