Road Rail Vehicle National Project – Human Factors Observations

2 Human Factors observations

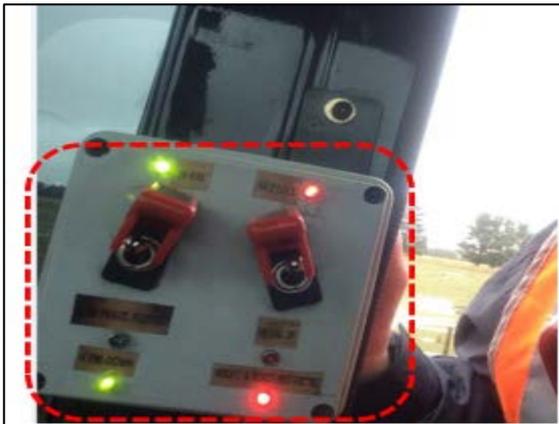
Figure 1. Two vertically-oriented toggle switches; 6 status lamps (of which 4 are shown illuminated); dymo-tape labels.

Located high on door post on left side of cab adjacent to entrance.

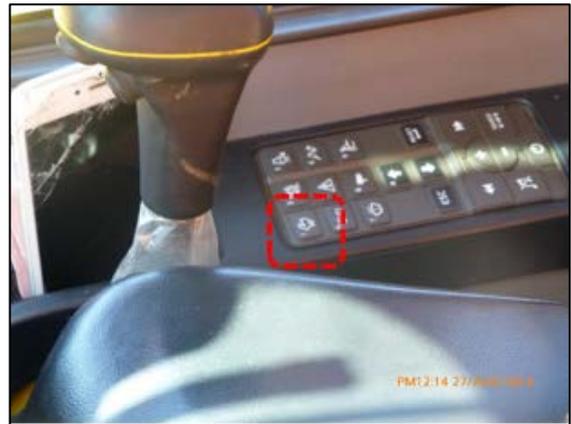
Figure 2. One press button; no status indications; one un-labelled and ambiguous symbol on button.

Located on multi-function control panel at lower right side of driving seat.

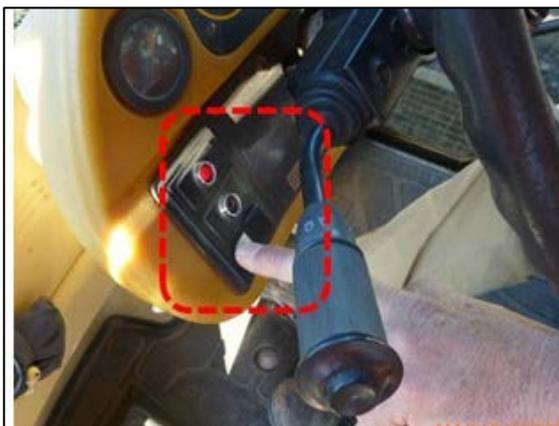
Figure 3. One horizontally-oriented (left / right) rocker switch (finger shown pressing to left side); 2 status lamps; no labels.

Located on left lower face of the front console.

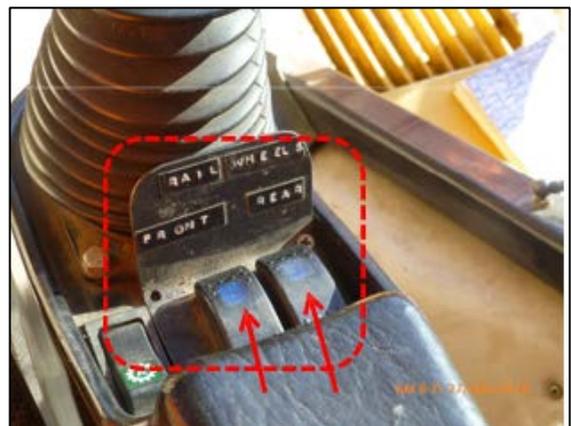
Figure 4. Two press switches (arrowed); switches appeared to contain blue-coloured embedded indicator lamps but these did not illuminate; dymo-tape labels.

Located in recess behind the main control stick just forward of driver's right arm rest.

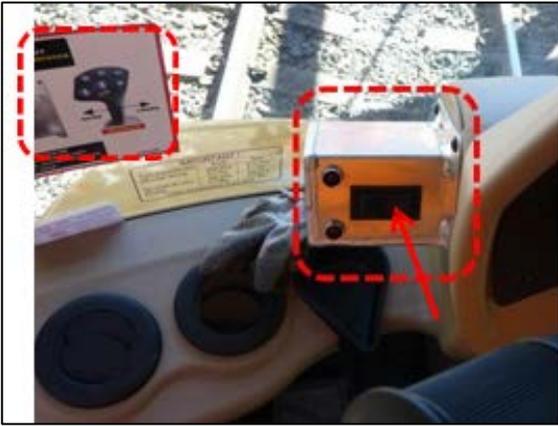
Figure 5. One horizontally-oriented (left / right) rocker switch (arrowed); 2 status indicator lamps; no labels. A separate windscreen sticker (at the left of photo) with somewhat convoluted instructions for use (see photo at right). Located on the left side of the front console.

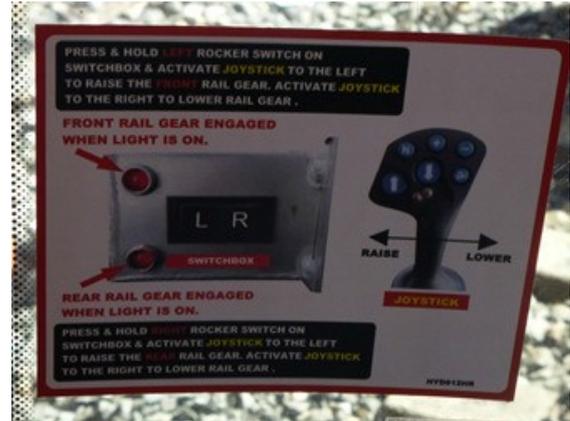
Figure 6. The separately located instructions sticker (refer RGS in photo at left). The left / right rocker switch (which activates front and rear rail wheels, respectively) is labelled on the sticker as “left / right” rather than “front / rear”.

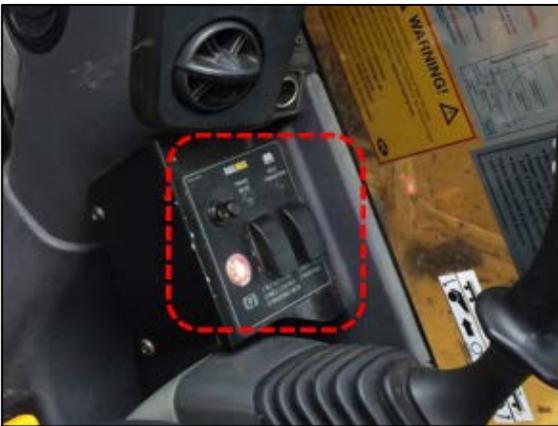
Figure 7. Two forward / back-oriented 3-position slide switches; 2 status indicator lamps; dedicated labelling. Park brake was also located on this panel.

Located on low console in front and to the right of the main control stick.

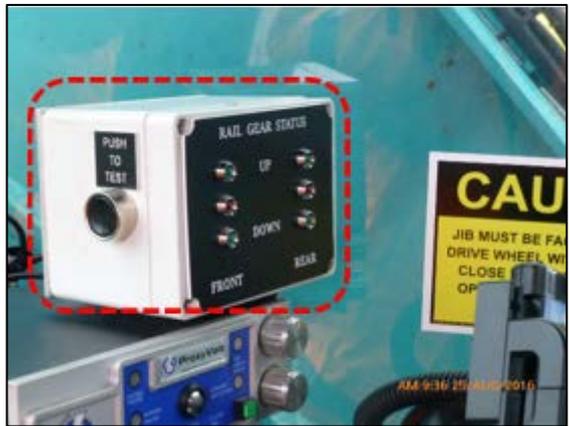
Figure 8. RGS status display only (controls located separately); 6 status indicator lamps; dedicated labelling; lamp test button function.

Located in front and to the right of the driver at just below eye level and above other equipment (radio; rear view camera display monitor; etc.).

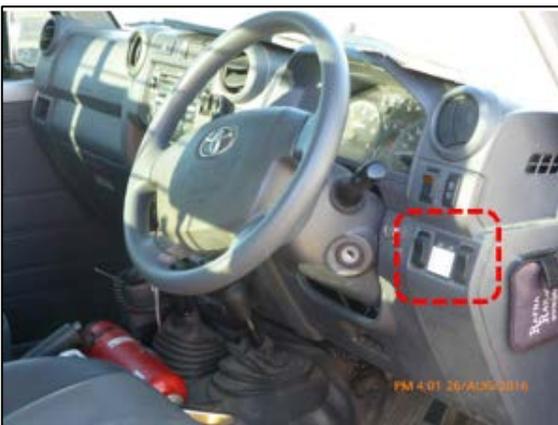
Figure 9. Older type RRV: 2 vertically-oriented rocker switches; 2 status indicator lamps; dedicated labelling.

Located low and to the right of the steering wheel on the front dash housing.

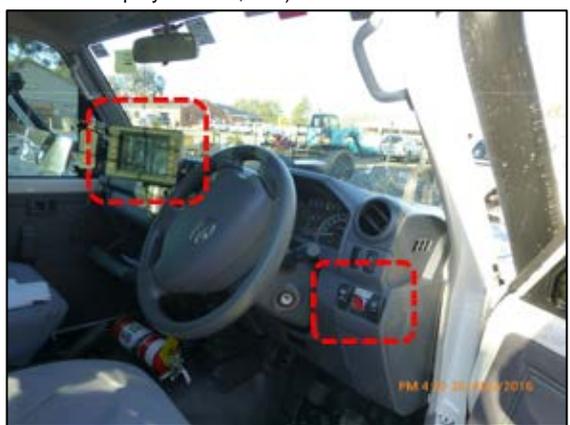
Figure 10. Newer type RRV: Touch-screen interface with RGS controls (at left); separate “Hyrail” park brake release button (at right).

Touch-screen located to the driver’s left side, projecting from the dash attachment. Park brake release button located low and to the right of the steering wheel on the front dash housing.

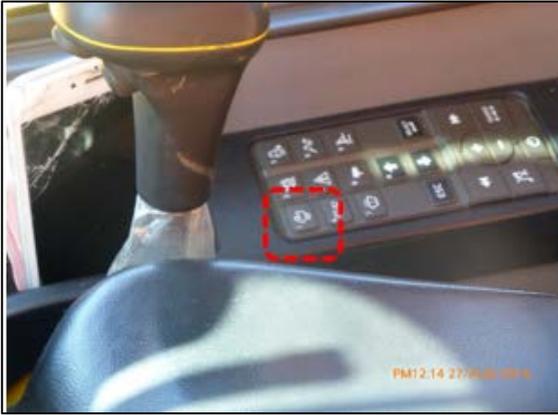
Figure 11. Copy of Figure 2 showing close proximity of numerous soft-key press-buttons for differing functions. See Figure 12 (at right) for close-up.

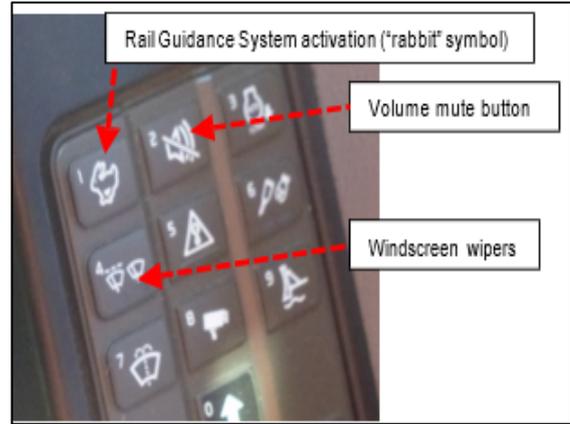
Figure 12. Close-up of Figure 11 showing close proximity of controls adjacent to single RGS control. The potential for inadvertent activation of adjacent switches is clear.

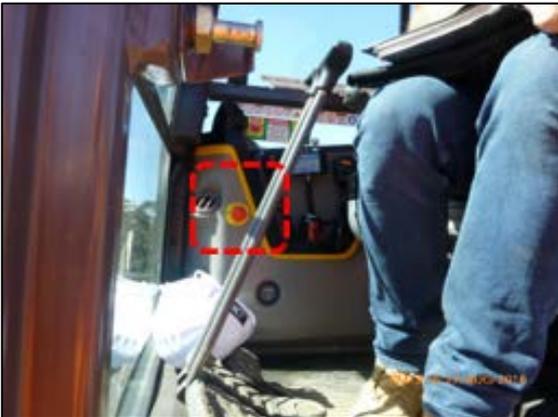
Figure 13. Interior Emergency Stop push-button: located low on the right cab interior wall; well outside driver's primary visual field.

The location of the Emergency Stop Button (ESB) varied between vehicle types. This presents a significant safety risk because the conditions under which a driver may have to activate an ESB are, by definition, emergency conditions when human response time is critical.

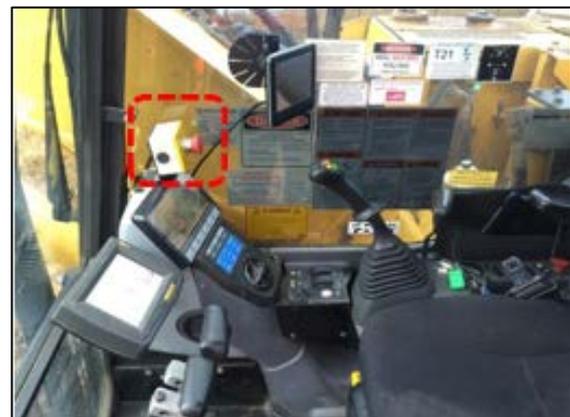
Figure 14. Interior Emergency Stop push-button: located above the front equipment array and well within the driver's primary visual field.

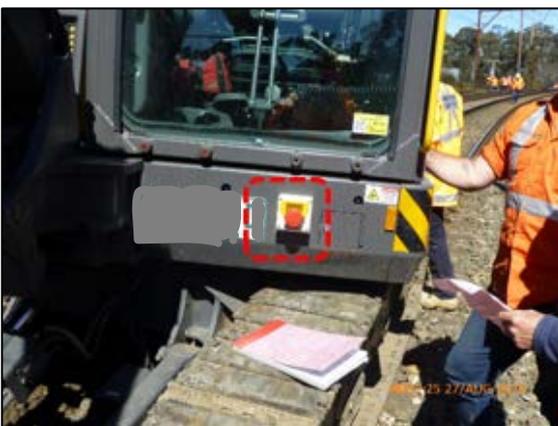
Figure 15. Exterior Emergency Stop push-button: located at the front of the vehicle; requires reaching across the excavator's tracks in order to activate; infringing kinematic envelope.

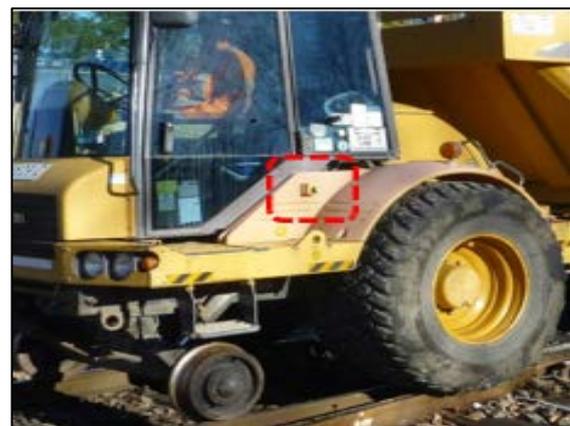
Figure 16. Exterior Emergency Stop push-button: located on the left side of the vehicle; requires reaching in close proximity to rear road wheel in order to activate.

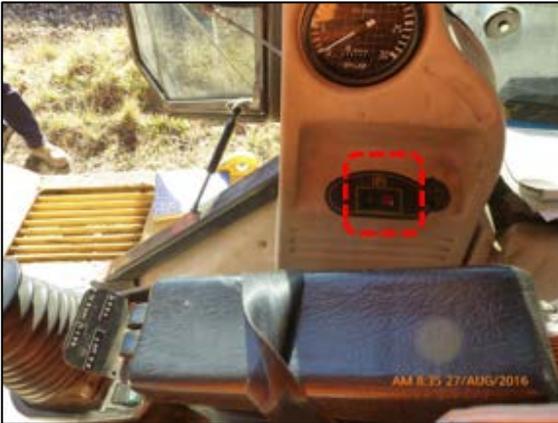
Figure 17. Most vehicle park brakes were located low and to the right rear side of the driving position, well outside of the driver's visual field.

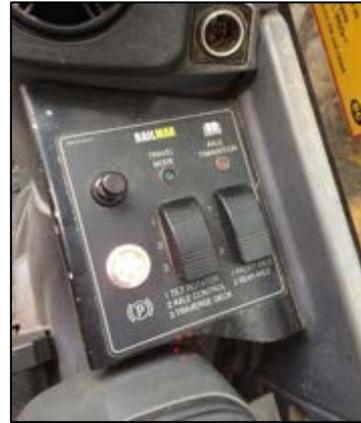
Figure 18. Park brake for RGS co-located with the RGS operation switches.

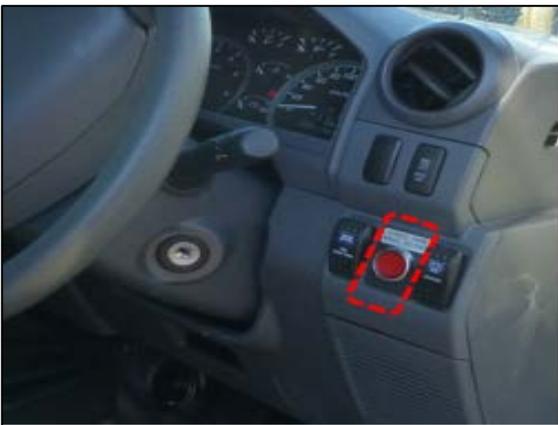
Figure 19. Hi-rail parking brake release button (*not* application button) located low and to the right of the steering wheel on the front dash housing. Park brake application was activated via the touch screen.

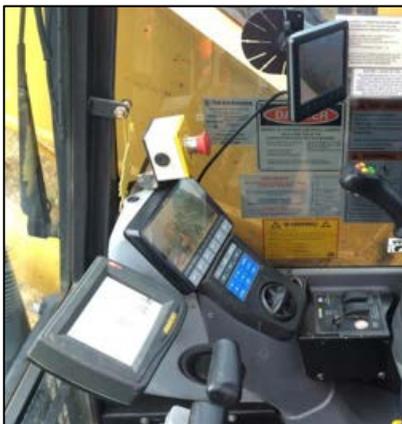
Some screen-based equipment observed (e.g., Figure 21) appears to have incorporated some limited shrouding to mitigate glare / reflection, while others (e.g., Figure 20) do not, and appear to have been installed in an orientation that would maximise reflection and glare.

Figure 20. Multiple in-cab screens and displays.

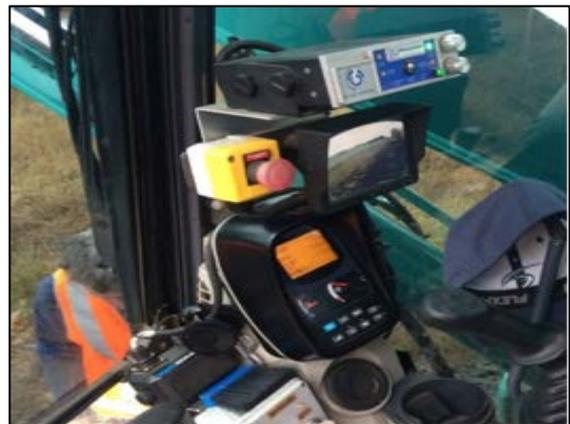
Figure 21. Multiple in-cab screens and displays.

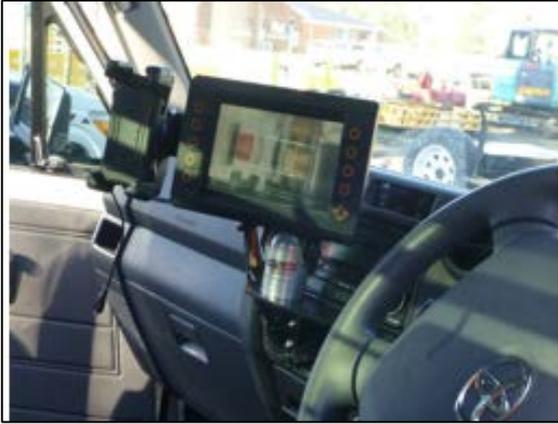
Figure 22. Touch screen installed in newer RRVs.

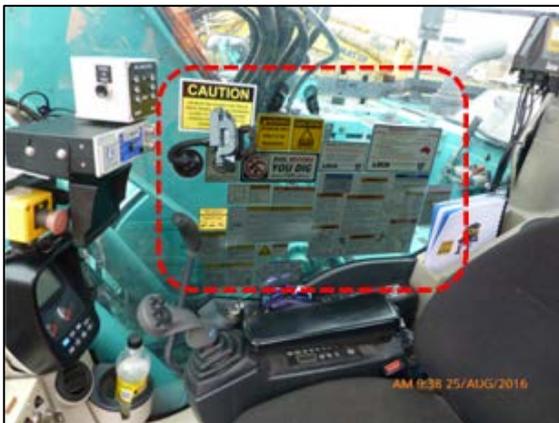
Most of the RRVs inspected featured an excessive number of information stickers placed over a significant portion of the available window space (see Figures 23 – 26). These stickers featured compelling title words such as “Warning”, “Danger”, “Caution”, “Notice” and similar.

Figure 23. View of stickers on right-side cab window.

Design issue	Risk	Comments / Controls / Recommendations
<p>Ineffective visual information and visual clutter</p>	<p>Placement of an excessive number of (apparently unused) signs / stickers over the driving cab windows presents an unnecessary level of visual clutter, much of it within or close to the driver's sightlines when operating the vehicle.</p> <p>These are unnecessarily distracting and, in some cases, potentially obscure a portion of their view of the vehicle surroundings, presenting the risk that a driver may not notice an impending collision (with persons or structures).</p> <p>Informal discussions suggest these notices are being displayed as an exercise by equipment suppliers to avert what they assume may be the potential for legal liability if, in the event of an incident, they appear to have failed to draw important information to the driver's attention.</p>	<p>A more effective and efficient approach for the notices that manufacturers believe must be available to drivers would be for these to be incorporated into the Equipment or Operations Manuals where they could be readily found under the appropriate contents heading.</p> <p>Their content should also necessarily form part of the training and competency assessment for RRV operators.</p> <p>A task and needs analysis may assist in determining which are essential for display (and where).</p>

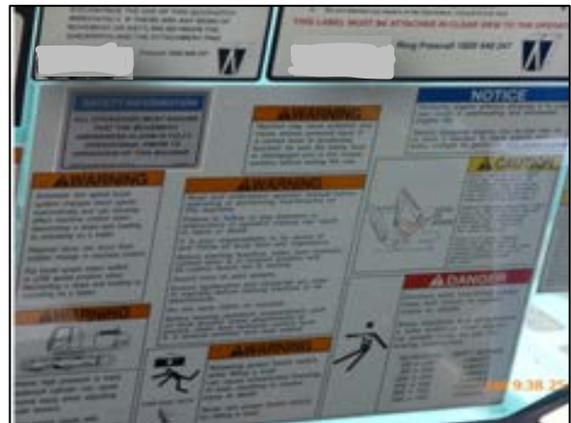
Figure 24. Close-up of stickers.

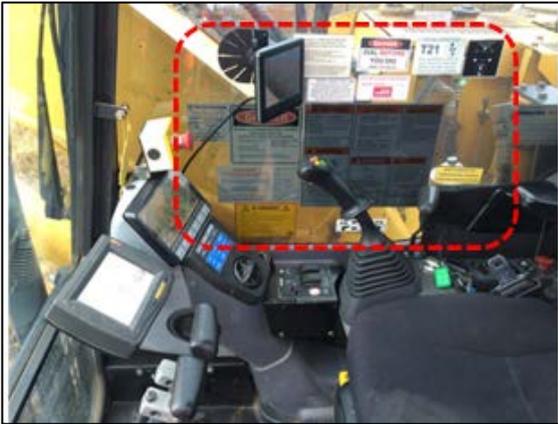
Figure 25. View of stickers on right-side cab window.

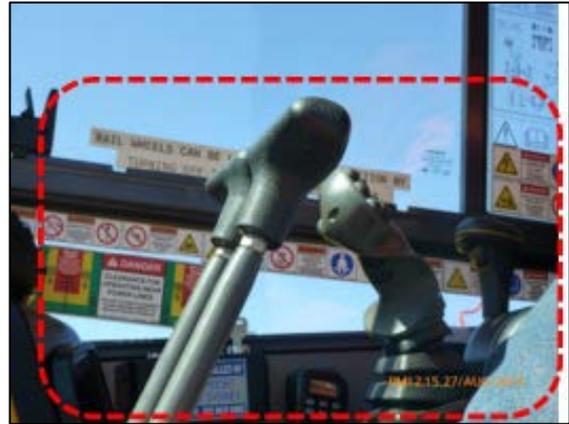
Figure 26. View of stickers on right-side cab window.

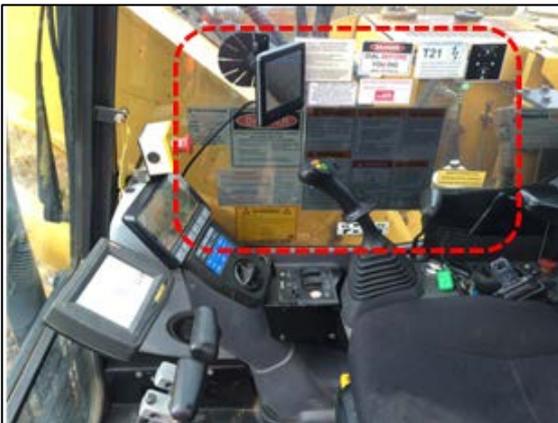
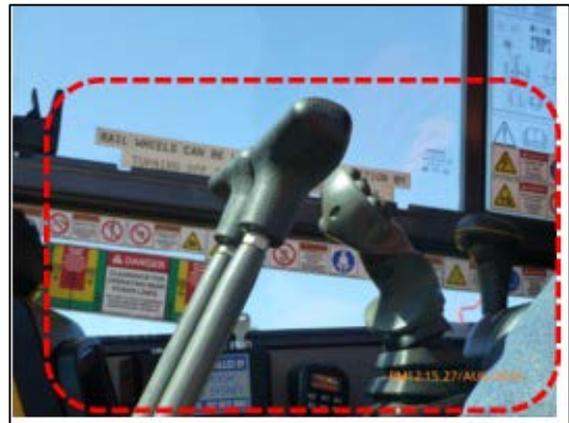
Figure 27(b)

Figures 27 (a) and (b) appear to provide some support for the view that the various warning stickers placed about the vehicle are, in this case at least, ascribed little-to-no importance; i.e., the “Danger” of which the sticker warns has been completely obscured by the registration

Figure 27(a). The vehicle registration plate has been affixed partly over a “Danger” sticker, concealing the nature of the danger of which it warns. See also Figure 27(b).

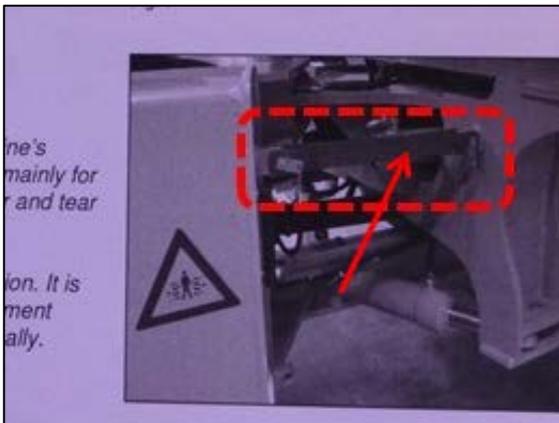
By contrast, the equipment manual for these trucks explicitly stated that the pivot joint lock must "*always*" be mounted when driving on the rails "*for safety reasons*" and also to "*prevent excessive wear*" (refer Figures 28 – 30).

Figure 28. Excerpt from an articulated dump truck manual. The photograph shows the pivot lock bar (arrowed) in the horizontal locked position (cf. Figure 30 [the same view] where the bar is clearly not in the locked position).

When driving on rails, always ensure that the machine's mechanical pivot joint lock fig.8 is mounted. This is mainly for safety reasons, but also prevents unnecessary wear and tear of the rail wheels.

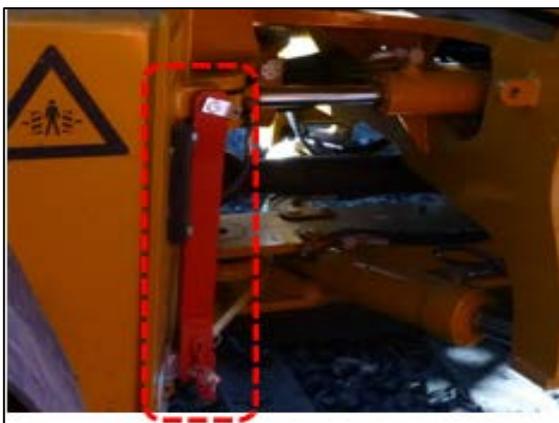
Figure 30. View clearly showing the pivot lock (red bar) not locked in place. The RRV was on the rails at the time. Notably, the pivot lock bar appeared new and showed no indication of use.

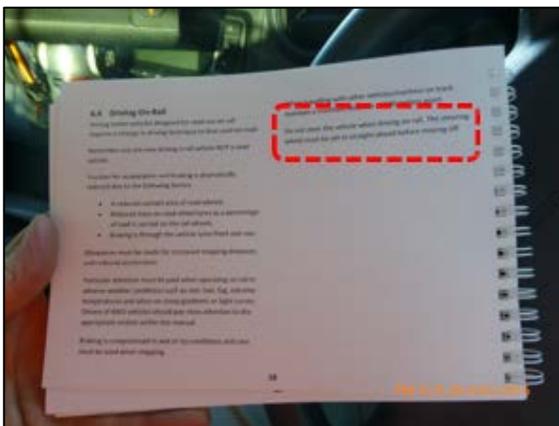
Although a seemingly important safety-critical requirement to prevent potential for derailment, this instruction is quite inconspicuous, only appearing in normal text and not until page 18 of the Manual (see Figures 31 – 32).

Figure 31. Essential information regarding the safety-critical instructions for steering wheel position and avoidance of steering appears only in an inconspicuous paragraph in the Operating Manual for the RRV.

<p>Inconspicuous safety information: While some safety- critical information was highlighted conspicuously in the Operating Manual, the information related to steering was not. This presents a risk that this information is either missed, forgotten or misunderstood as not important for safety.</p> <p>Incorrect operating manuals in vehicles: In some cases, the Operating Manuals in the RRVs was for the OEM vehicle and contained no information about the RGS or working on rail.</p> <p>Ambiguous (and therefore ineffective) warning: In one observed case, a conspicuous warning sticker about an apparently safety-critical (braking) function was present. However, that function ("<i>brake proportioning valve</i>") was not known by personnel on site, nor was the manual relevant to it available in the vehicle.</p>	<p>In relation to documentation within vehicles, there are several reasonable expectations:</p> <p>As part of a sound safety management system, a vehicle (of any type, including RRVs) should contain such documentation as necessary to enable safe and effective operations. This usually includes, as a minimum, vehicle-specific operating manual, log book, pre-start inspection checklists, incident report forms, and any other necessary safety-related documentation.</p> <ul style="list-style-type: none"> > Pre-start inspection checklists should clearly delineate between tests and inspections that should be performed prior to or after engaging rail mode. > Documentation should be specific to the vehicle in which it is held. Where the vehicle has been retro-fitted with additional functions (e.g., a RGS), the vehicle manuals should either be updated or additional operational documentation related to the extra functions should also be held in the vehicle. > Documentation should have been subject to review such that: <ul style="list-style-type: none"> ▪ the information it contains is both accurate and applicable to the vehicle; ▪ there is no conflict between information in the documents and that contained elsewhere (e.g., in procedures or SWM documents); ▪ the information (especially if safety-critical) is both conspicuous and made relevant to the applicable users (e.g., RRV operator; maintainer)

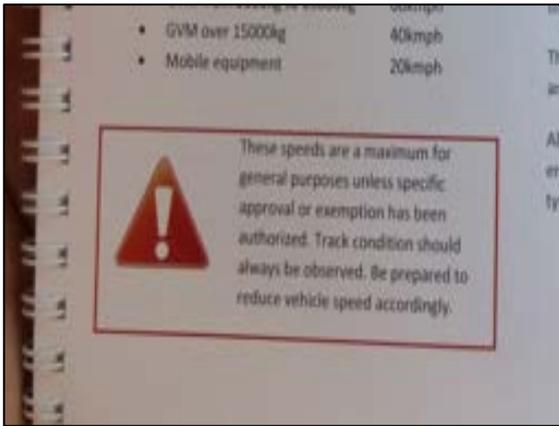
Figure 33. Example of other important information being conspicuously highlighted in the Operating Manual.

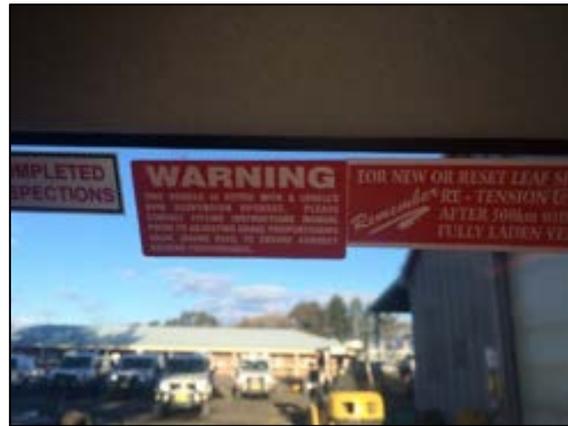
Figure 34. Warning and information stickers placed on interior of vehicle's windscreen.

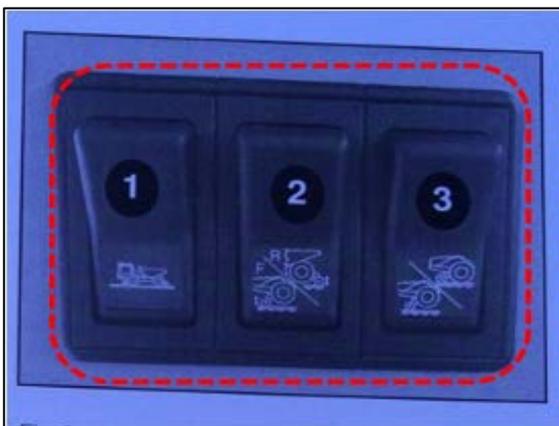
One RRV which was relatively new, had an operating manual containing instructions for a RGS that was entirely different to that actually installed in the vehicle (see Figures 35-36).

Figure 35. An image from the articulated dump truck RRV Operating Manual showing an RGS switch configuration entirely different to that which was installed (see Figure 36).

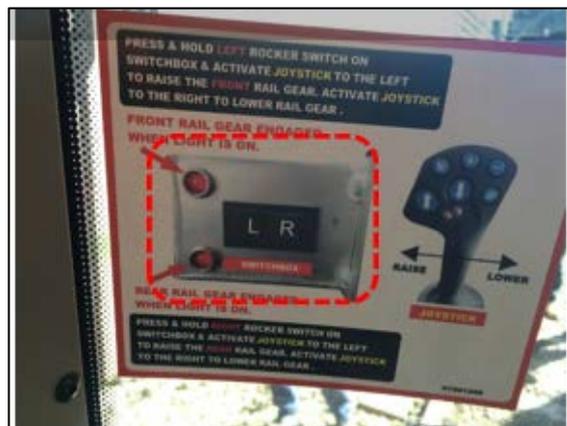
Figure 36. An instruction sticker in the same RRV showing the actual RGS controls. These are completely different to those shown in the Operating Manual held in the vehicle.

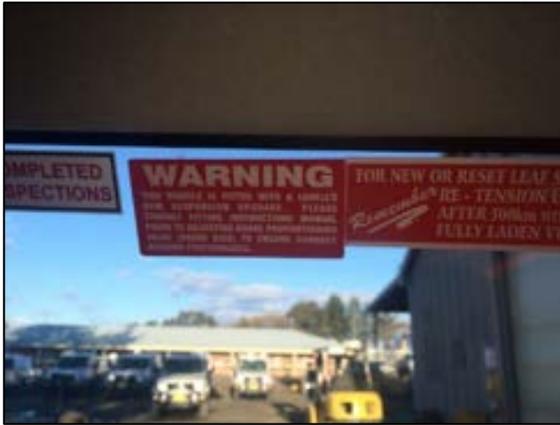
One type of RRV featured a number of stickers at the top of the windscreen. One of these was a conspicuous "Warning" sticker with the following instruction (see Figure 37 – 38):

Figure 37. Numerous information stickers placed at the top of the RRV windscreen.

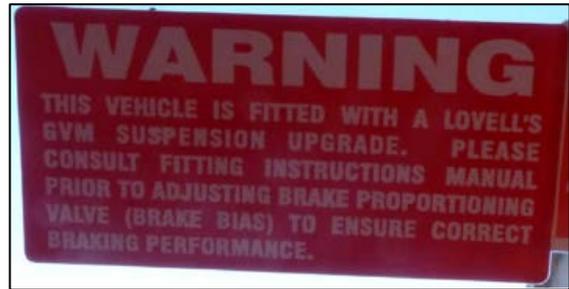
"Please consult fitting instructions manual, prior to adjusting brake proportioning valve (brake bias) to ensure correct braking performance."

- > the vehicle did not contain a “*Fitting Instructions Manual*”,
- > the personnel on site did not know what a “*brake proportioning valve*” was, and
- > given that the sign was emplaced directly in front of the driver, it was unclear whether this is something that should be done by the vehicle driver / operator on each trip or, alternatively, something done either during initial installation or during periodic maintenance.

In summary, the use of a red, visually compelling “Warning” sign is confusing and ineffective if there is no immediately available information about its meaning.

Figure 38. Close up of the “brake proportioning valve” warning sticker.
