Document ID:	ONRSR-1450117371-47
Rail Safety Alert No	RSA-2024-001
Date Issued	16 April 2024

Risk of uncontrolled movements associated with direct drive hydraulic pumps installed on Road Rail Vehicles (RRVs).

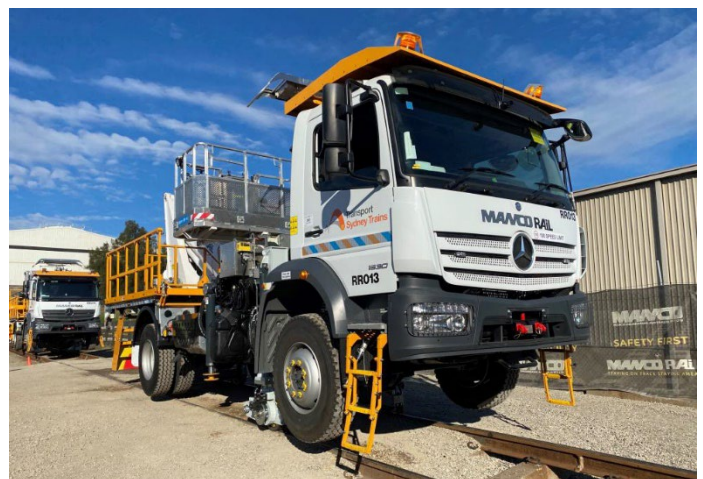
The uncontrolled movement of a Manco RRV truck mounted EWP (Elevated Work Platform) on 16 December 2023 was outlined in ONRSR's Safety Alert RSA-2023-0002 dated 21 December 2023. The truck that referred to is pictured below.

The RRV is driven on rail through its front wheels by a hydraulic pump directly connected to the truck engine (direct drive). The hydraulic pump in this type of drive system generates hydraulic pressure while the engine is running. A controller spool valve determines how much of this available hydraulic flow and pressure is transmitted to the rail wheels, which in turn controls the speed and torque at the rail wheels.

The RRV was reversing in EWP working mode at the time of the incident, meaning it was under the control of an operator in the EWP bucket. The operator moved the joystick to neutral to slow down, but due to the pump controller spool being jammed, instead of slowing down the RRV, reversing speed increased. The operator applied the emergency-stop function, which did not cut off drive to the front wheels and arrest acceleration. Movement was eventually brought under control only by the truck being switched off in the driving cab.

- Reports from the hydraulic pump manufacturer indicate that the controller spool valve had jammed likely due to contamination entering into the hydraulic fluid.
- The emergency-stop function's failure to cut off drive was likely due to its incompatibility with a novel drive configuration on the Mercedes donor truck.
- The emergency-stop function correctly applied brakes. However, in EWP working mode, only the rear wheels are braked. The rear wheels are lightly loaded due to the weight distribution of the RRV, and it is thus likely that they skidded and lost their braking efficacy.

Manco and Sydney Trains have reported to ONRSR that they, and the hydraulic pump supplier, are introducing both improved operator awareness and E Stop functionality along with a secondary back up control system in the event of a controller spool jamming again on direct drive engine couplings.

- a) Adequate design rigour and risk management associated with hydraulic pump characteristics and with novel drive configurations on donor trucks.
- b) Enough emergency braking effort to overcome driving force under all circumstances.
- c) Identification and control of all possible malfunctions causing uncontrolled movement during the overall certification process.
