# Notice to Rail Transport Operators

## Safety Alert

Document ID:	ONRSR-1450117371-44
Rail Safety Alert No	RSA-2023-0002
Date Issued	21 December 2024

Incidents involving rail equipment manufactured and/or supplied by Manco Engineering Group (Manco).

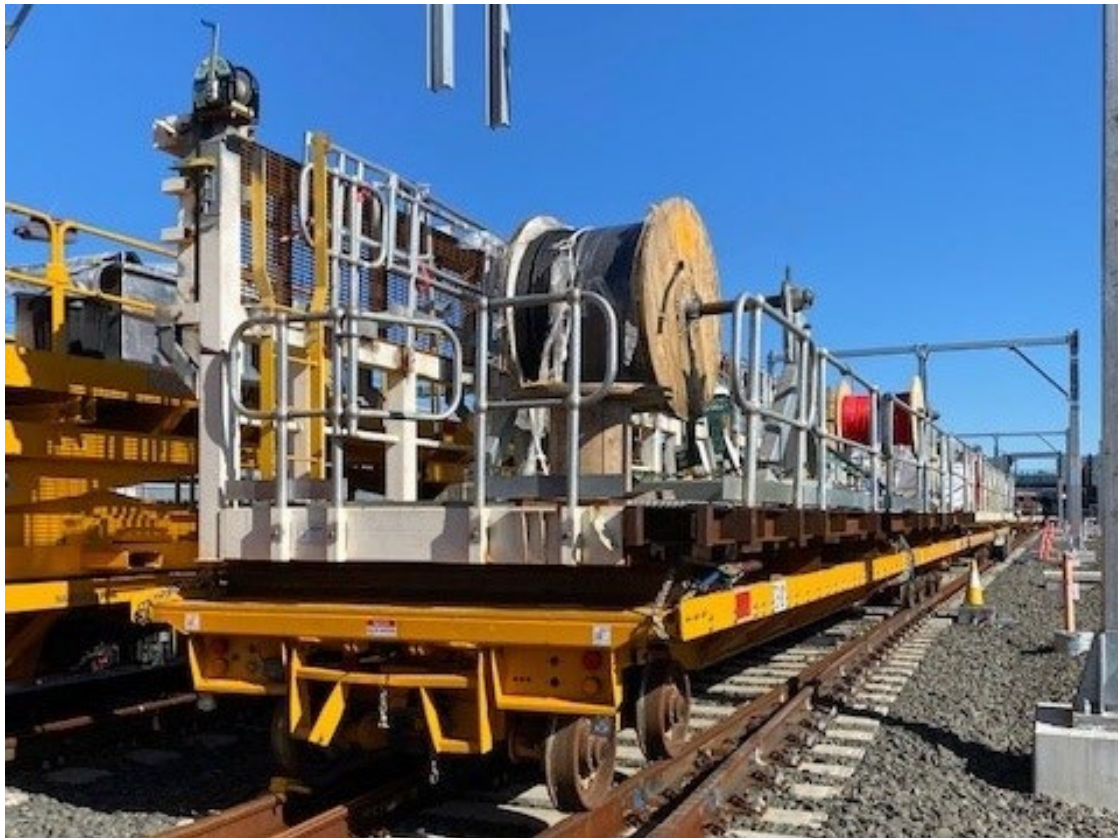
On 16 July 2022, a 30-ton infrastructure trailer ran away unbraked from the entrance of the new Sydney Metro City and Southwest tunnel at Sydenham, NSW for a distance of over 1.5km.

Figure 1: Runaway trailer loaded with wire coils – GVM 30t

The first failure, in the case of this incident, was that the pin and ring did not engage as designed and this was not detected.

As a result, the runaway trailer separated from the rest of the train and the brake pipe disconnected – an occurrence known as unintended train separation.

Rail Transport Operators should examine all risks associated with operating infrastructure trolleys and trailers. Examinations should cover all types of road rail vehicles, trailers, trolleys and any other rolling stock coupled to them and not be limited to the specific type of equipment involved in this incident.

All braked vehicles in trains must undergo fail-safe automatic emergency brake applications in the event of unintended train separation. The emergency brake application must occur regardless of where the separation is, and regardless of the direction the vehicles are facing relative to each other in the train.

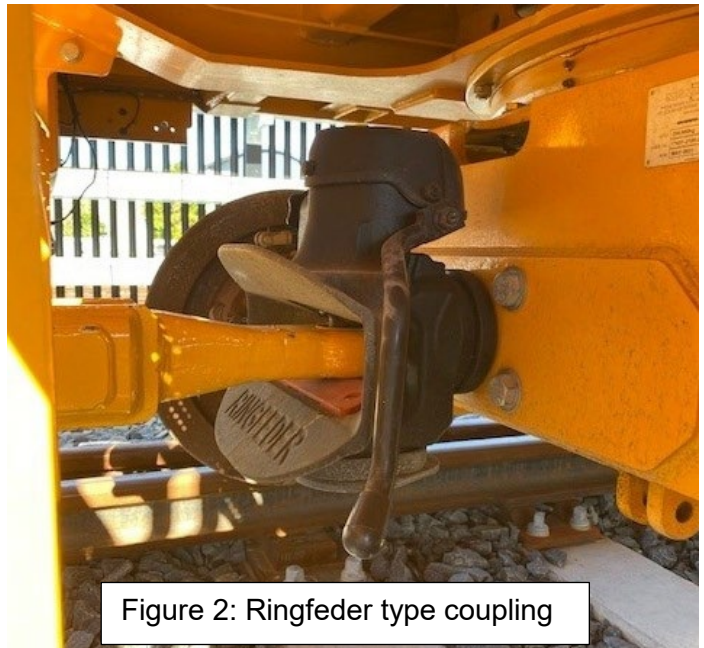
The trailer was equipped with Ringfeder type couplings typically found on road trucks and trailers, which have a pin that drops through the drawbar ring when coupled.

Figure 2: Ringfeder type coupling

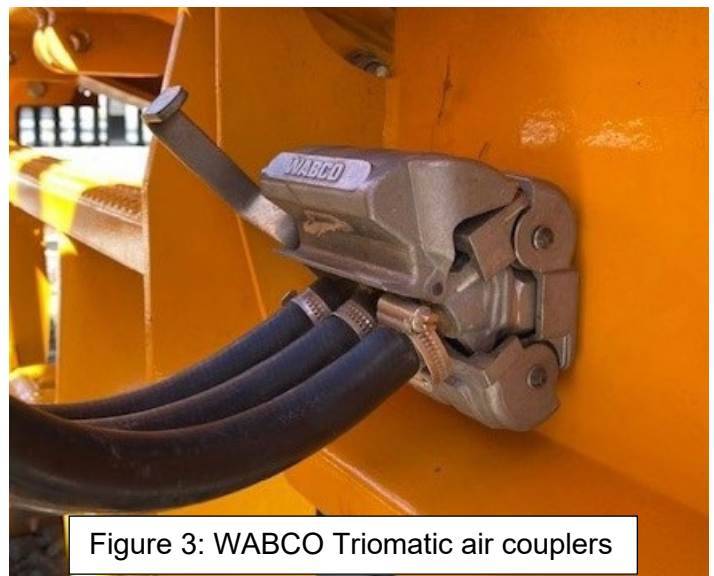
The second failure was that the brakes did not apply when the unintended train separation occurred.

The brakes did not apply because the runaway trailer was fitted with WABCO Triomatic air couplers. These couplers have an automatic seal function meant for fitment to the rear of road trucks to preserve the truck's air when the brake pipe disconnects. The fitment of this equipment to trailing rolling stock was erroneous and unsafe.

Figure 3: WABCO Triomatic air couplers

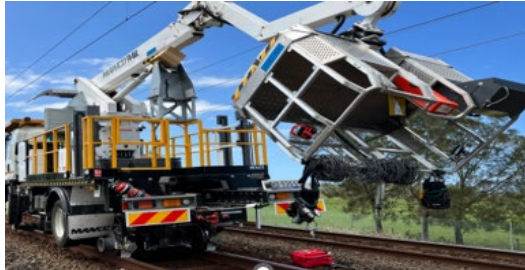
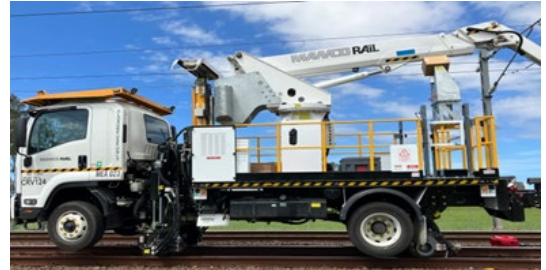
This Safety Advice is to inform all workers about a recent serious incident involving a Manco-fitted EWP that sustained a mechanical failure during operation in Queensland.

- Two workers were subject to head lacerations after falling five meters from an EWP on 18th November 2023.
- The workers were working on an overhead rail wire when the mechanical failure caused the bucket to tip.
- The workers were taken to the hospital for further treatment and assessment.

Sydney Trains has undertaken a review and inspection of its Manco fleet and has directly engaged with Manco requesting further testing be undertaken to ensure the defect is not present. This review has included both internally owned and externally hired units.

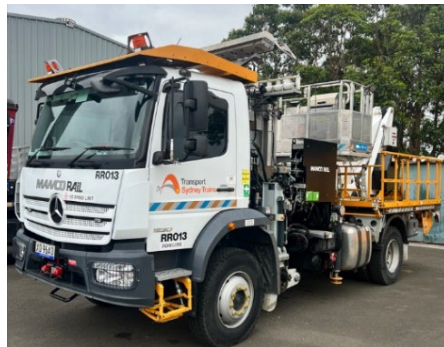
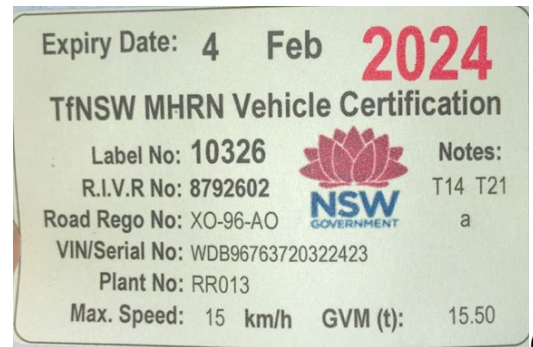
An incident involving a runaway movement recently occurred when City South Territory Electrical Infrastructure workers were conducting routine maintenance inspections on the 1500v Overhead Wiring System using a Sydney Trains managed Manco Hi Rail Truck Mounted EWP (Model SCF14).

- A worker in the basket operated the controls to move the machine down the track to the next work position. This resulted in the machine moving at higher speed than what was expected when the EWP mode was engaged.
- The machine did not stop when the hand control and Deadman foot pedal were released and the machine continued travelling at a speed estimated to be between 20 -25km/hr.
- The uncontrolled movement resulted in the Operator being struck by an Overhead Wiring (OHW) component.
- The Operator activated the *Emergency Stop* button, which did not stop the machine from travelling.
- It has been confirmed that the *Emergency Stop* function is not designed to include an engine shutdown.
- The machine was stopped approximately 100 metres from its original position by the Protection Officer sitting in the cab of the EWP who was able to turn the ignition key off.

Figure (a) machine involved in the incident and b) Vehicle Certification Label of the machine.

- The injured worker was treated at hospital to receive medical care.
- A mechanic from *Manco* (Original Equipment Manufacturer of the EWP) attended site to investigate the cause of the incident.
- Immediate suspension of all *Manco* elevated work platforms.
- A systemic safety investigation into the incident is currently underway. While those investigations are underway, the machines of the same make and model will remain grounded.
- ONRSR and SafeWork NSW have been notified.
