Rail Industry Safety Notice

RISN No 1 / 2012

RAIL SAFETY INVESTIGATION REPORT

COLLISION BETWEEN HI-RAIL AND RAIL MOTOR

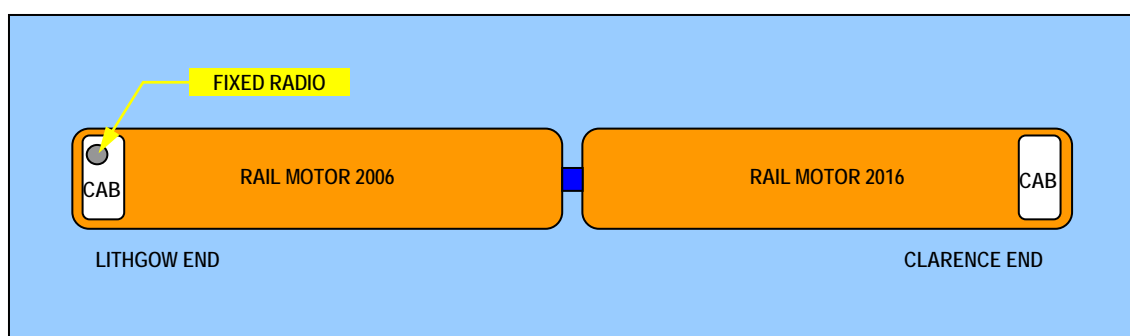
Figure 3: Two-car Rail Motor configuration

- 1.3 The Rail Motor Driver started the day at 8:30am and prepared the two-car Rail Motor for service. During this preparation, the Driver found that a brake block had been placed on the EP valve in each cab to prevent them from leaking and so allow brake pipe air pressure to be built up and maintained. The placement of a brake block, or any heavy object, on the EP valve also has the effect of rendering the deadman system inoperative.
- 1.4 The Driver removed the brake blocks from the Rail Motor and contacted maintenance staff. The EP valve was replaced in Rail Motor 2006 (see *Figure 3*) while the other was found to be serviceable to the extent that air pressure could be built up and maintained, so allowing the Rail Motor to enter service.

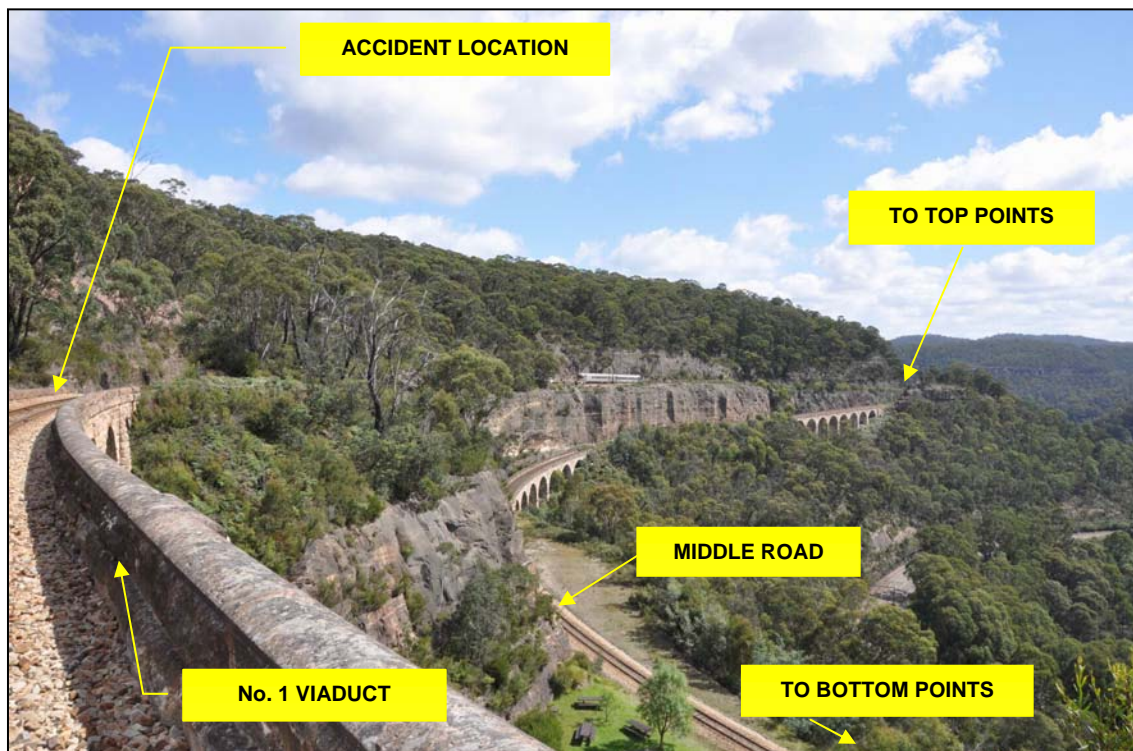
Photograph 1: View across top of No. 1 Viaduct

- 1.17 The Rail Motor then proceeded to Top Points, as scheduled, halting before No.1 Viaduct to allow the passengers to alight to view the Viaduct and obtain a panoramic view of the Zig Zag Railway (see *Photograph 1*). The passengers then rejoined the Rail Motor which continued to Top Points Station.
- 1.18 On arrival at Top Points Station at 1:24pm, the Rail Motor Guard took the passengers on a short tour around the station area while the Driver changed ends and drove the Rail Motor a short distance away and brought it to a stand adjacent to Top Points Signal Box (see *Photograph 2*).

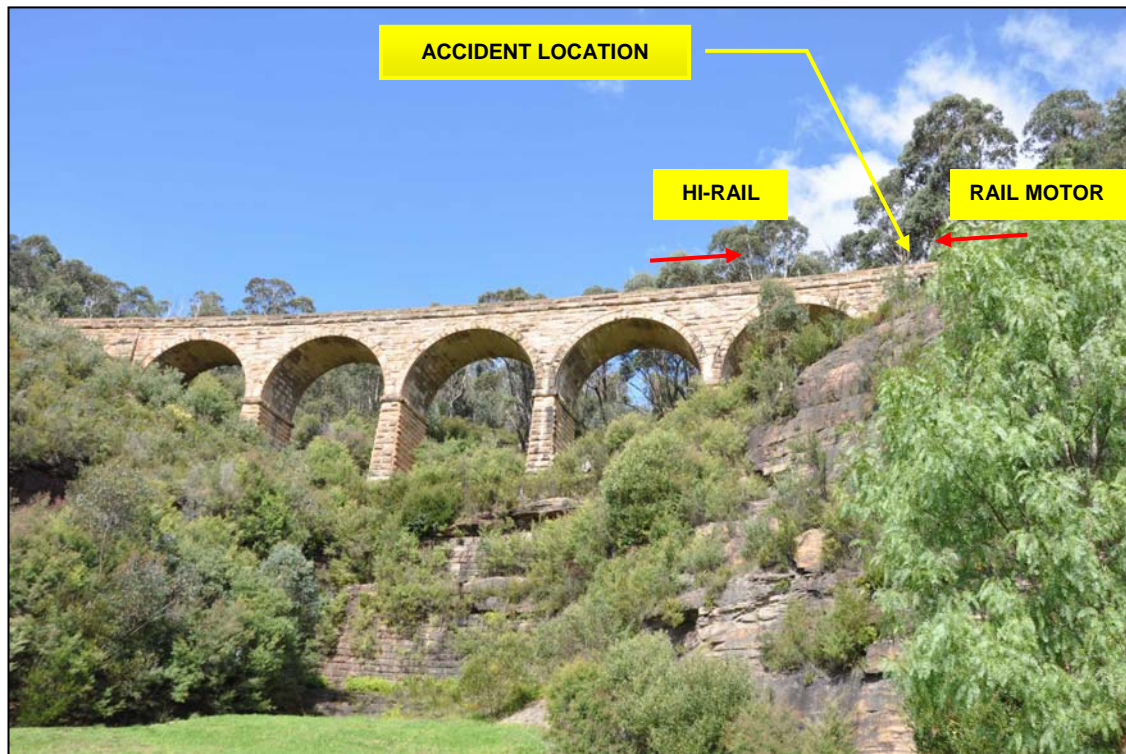
Photograph 4: No.1 Viaduct from below, looking South

- 1.25 The two occupants of the Hi-Rail traversed the Viaduct still unaware of the oncoming Rail Motor. Both occupants of the Hi-Rail stated that at no time did they either see or hear the approaching Rail Motor before the collision.
- 1.26 The rear of the Hi-Rail and front of Rail Motor collided on the No.1 Viaduct (see *Photograph 4*) at an estimated combined speed of 35km/h. The force of the collision was such that the front of the Hi-Rail was lifted in the air. The Passenger of the Hi-Rail said: “all I could see was sky”. He was concerned that they might have been thrown over the edge of the Viaduct.

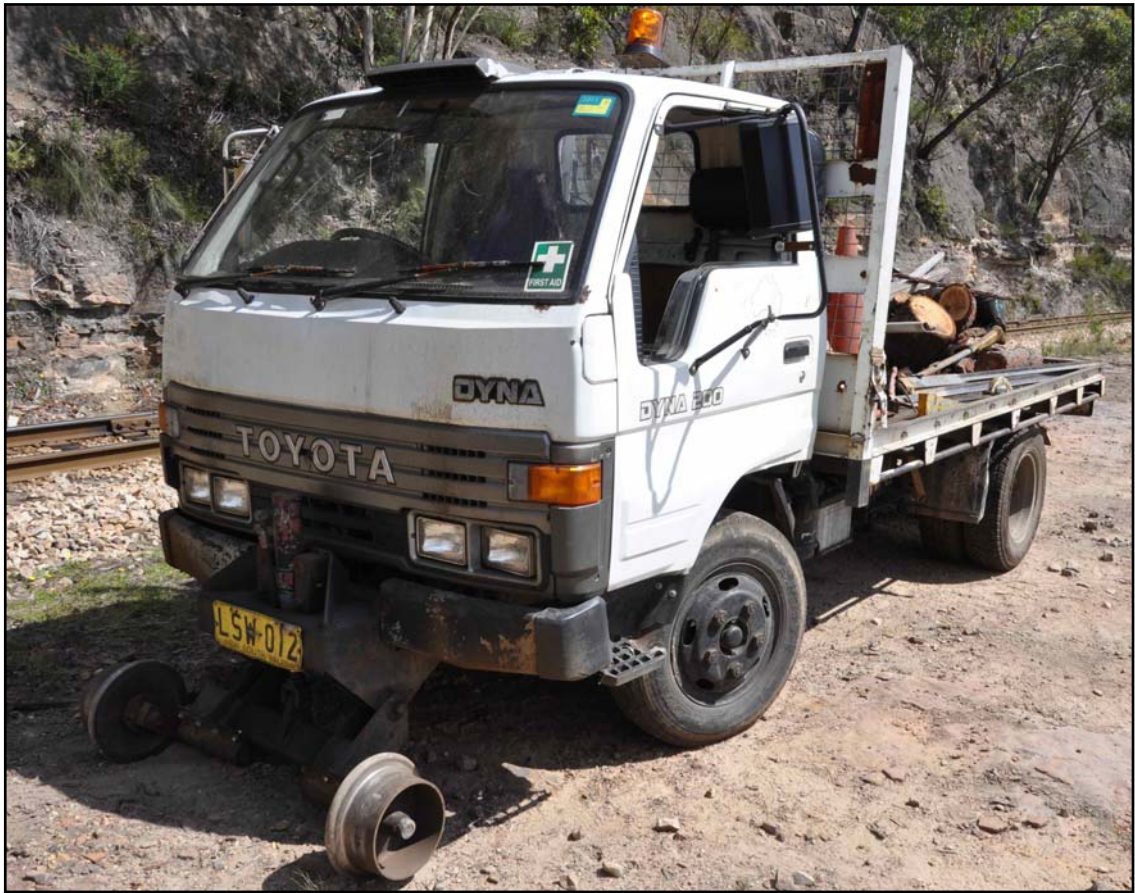
Photograph 7: Hi-Rail vehicle

- 1.48 The Hi-Rail is a Toyota Dyna truck (see *Photograph 7*), road registered until July 2011. It has a standard configuration of rubber tyres as well as being equipped with flanged steel rail wheels. The rail wheels can be raised or lowered using a hydraulic mechanism to allow it to be driven on track. It is used as a general purpose transport for tools and maintenance equipment around the rail infrastructure. On the day of the collision, the flat-bed tray was loaded with timber, star pickets, tools, oxy-acetylene gas bottles and detonators. Most of these materials and equipment were loosely loaded on the tray with some items stored in metal boxes and garbage bins.

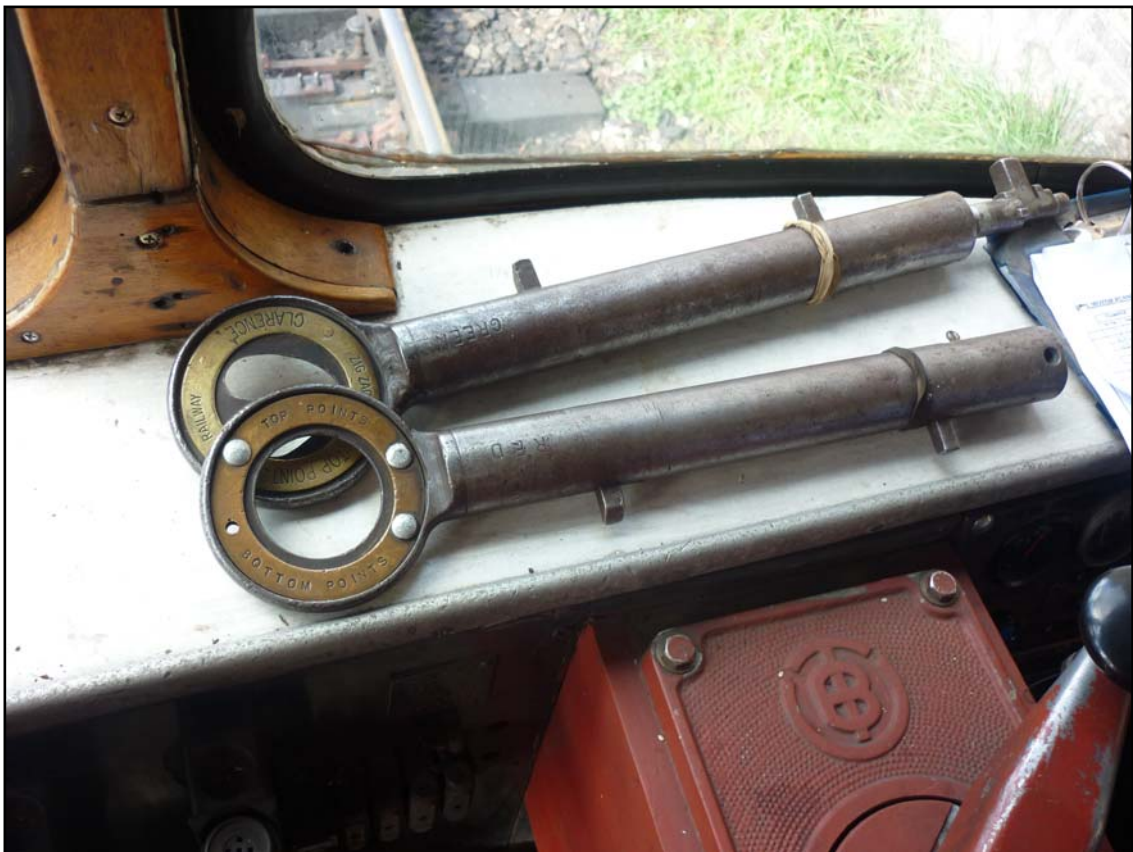
Photograph 8: Train Staffs

- 2.1 **Staff and Ticket Overview.** During normal operations on the ZZR, a Staff and Ticket system is used. This system is used on single lines to facilitate the safe movement of individual trains in either direction. It is a simple and effective system where a single Train Staff is provided for each section (see *Photograph 8*). Each Train Staff is engraved with the section name and the colour of the Staff Box. As well, in the eye of the Staff, there is a distinctive shape to assist in differentiating between Staffs.

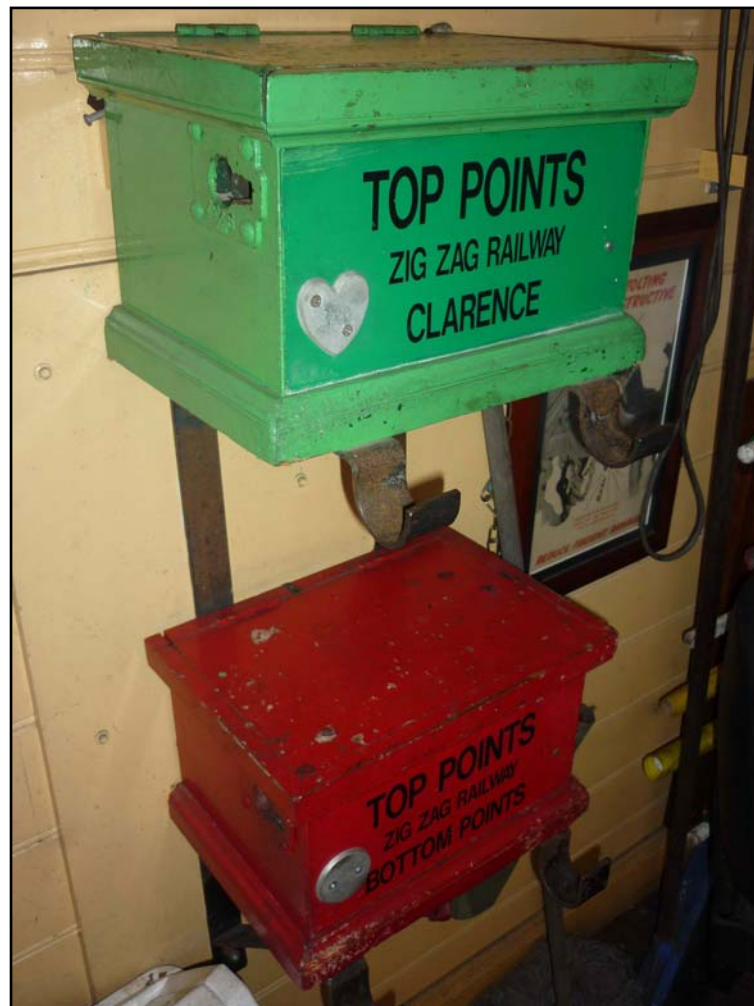
Photograph 9: Staff Boxes in Top Points Signal Box

The Staff is seen and verified by the driver of the first train and a Ticket is then written giving it authority to use the line. The next train is required to wait before entering the section until a message is received from the far end stating that the line is clear, then it is sent forward with the Staff (unless there is a third train headed in the same direction, in which case another Ticket is used). The tickets are pre-printed, consecutively numbered and clearly marked with the section name. Inside the signal box, Staff Tickets are kept in the Staff Box (see *Photograph 9*) which can only be opened with the correct Staff.
