Rail Industry Safety Notice

RISN No 5 / 2012

TRAIN BRAKE PIPE OBSTRUCTION FLEXIBLE AIRBRAKE HOSE

TECHNICAL ALERT – SIGRA railway Airbrake hose made to AS2435

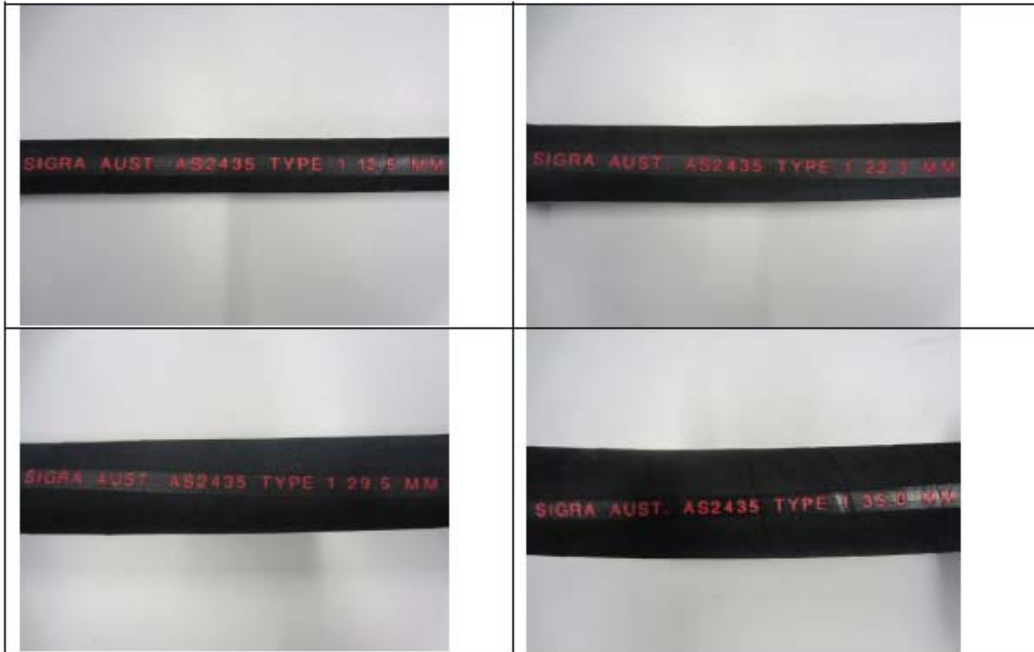
There are 4 different Sigra AS2435 Airbrake hose sizes – 12.5mm ID, 22.3mm ID, 29.5mm ID and 35.0mm ID. Details are marked in red raised letters on the hose layline which is repeated every 450mm. Other brands of hose have a visually similar layline, but will not be marked "Sigra Aust."

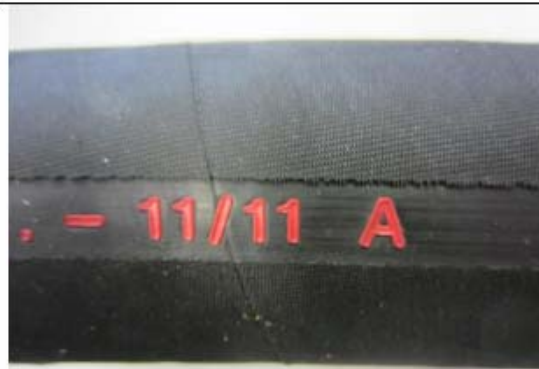
Hose manufacturing batch numbers are identified as shown. This hose is manufactured in November 2011, and an "A" suffix is always used in case two batches are manufactured in the same month. This has never happened, so all batch numbers have the "A" suffix

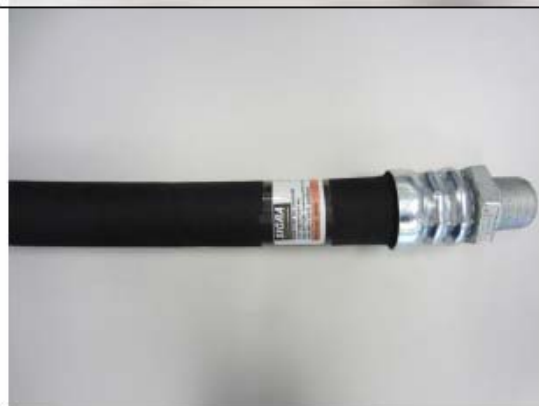
Sigra hose assemblies have a plastic label showing the hose assembly batch number, part number and customer details where applicable. The label is covered with a clear plastic band for durability and is placed close to the nipple end of an assembly.

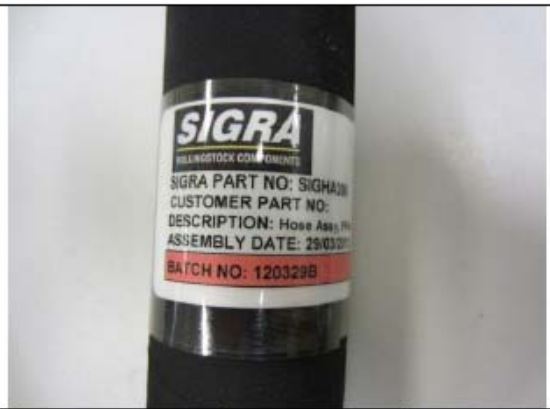
Closer view of a hose assembly label.

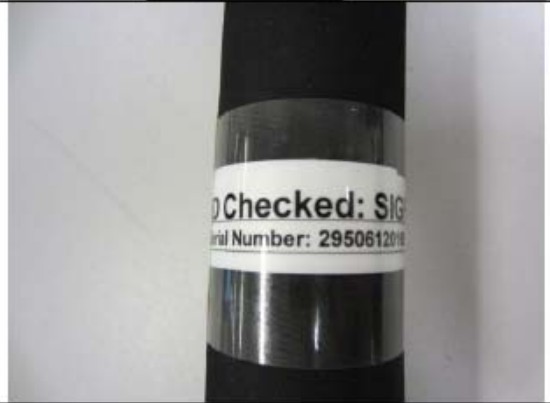
The ID Check label fitted to recently manufactured hose assemblies

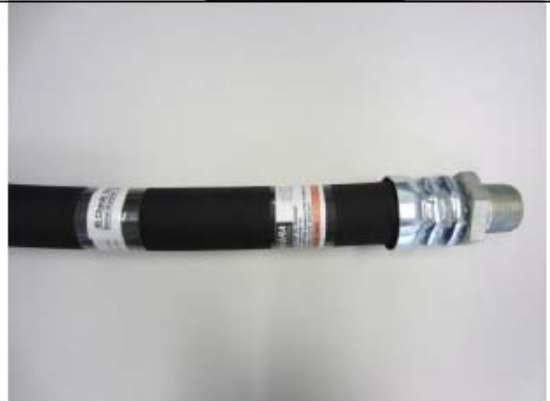
ID check label shown with the hose assembly label

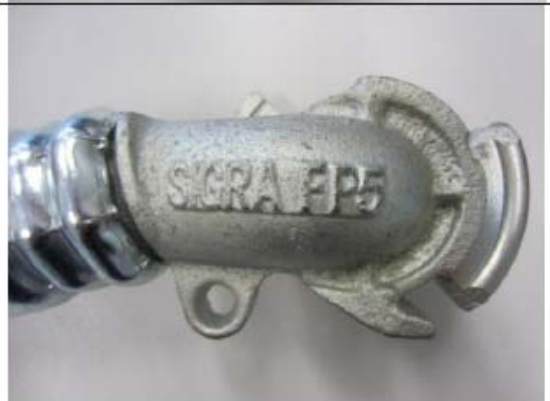
Sigra coupling heads can also be found on hose assemblies not manufactured by Sigra and using other hose not affected by the fault.
